**Cultural Resource Survey**

374 Acres (+/-) in Marion County, Mississippi  
Columbia North USGS Quadrangle Map  
Sections 34 & 35, Township 4N, Range 18W  
Gulf South Project Number DUN1-12-004

December 10, 2012

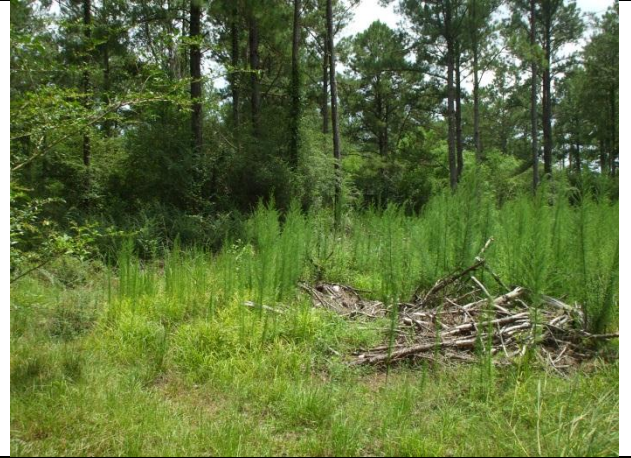
**PHOTO 15** – Photo taken facing south from the datum of site number 22Ma800, where three flakes were identified on the surface. All subsurface shovel tests in this area did not yield artifacts.

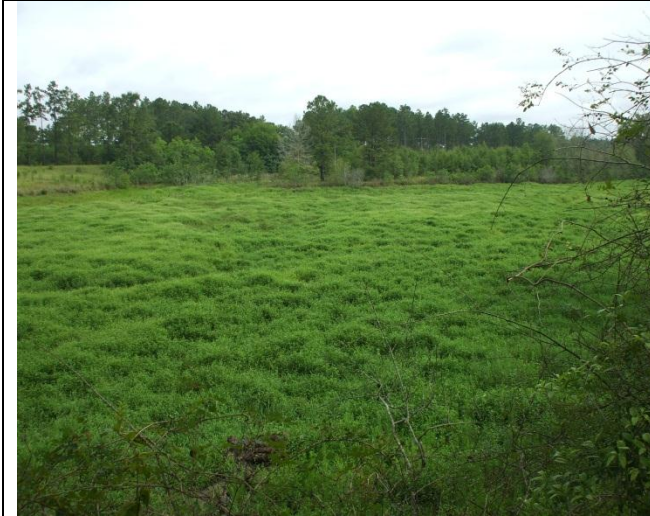
**PHOTO 18** – Manmade pond in the southwest quadrant of the survey property that is now drained and overgrown with vegetation. Photo taken facing north.

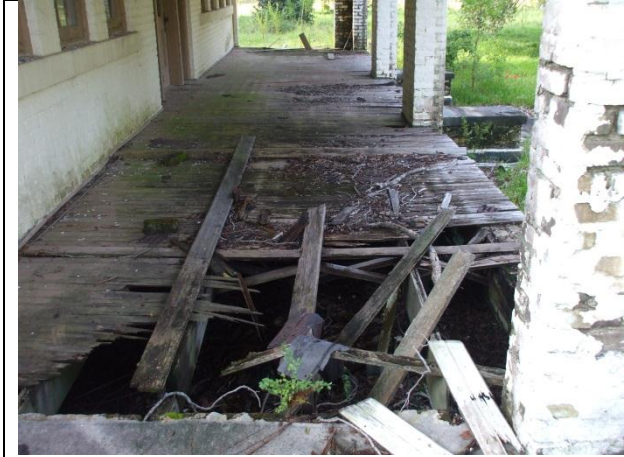
The Superintendent's Home is a two-story, stuccoed Bungalow with a gabled roof and Craftsman-style features (See Photos 38-45 in Appendix B). The foundation and walls are constructed with brick and the roof is composed of composition shingles. Heart pine timber was used in construction of the building and was never treated for termites. The front porch floor and interior floors have deteriorated and lost stability. Unstable footing inside the structure limited a survey of the interior. There are four bedrooms upstairs and two bedrooms downstairs. There are two bathrooms downstairs in addition to a formal dining area and kitchen.

**PHOTO 42** – SUPERINTENDENT'S HOME front porch

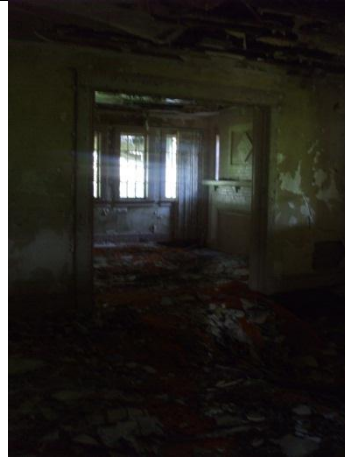
As of the site visit on September 4, 2012, the Superintendent's Home has experienced significant deterioration over the last 15-20 years. The exterior was observed but the interior could not be fully accessed because of unstable flooring.

**PHOTO 43** – SUPERINTENDENT'S HOME formal dining area. The floor has deteriorated and is unstable; therefore, the survey of the interior was limited due to safety concerns.

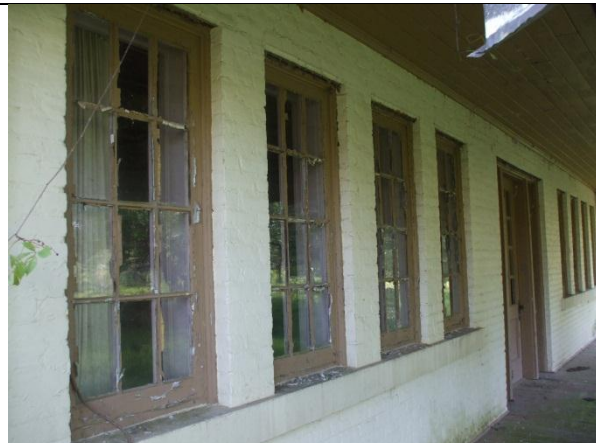
**PHOTO 44** – SUPERINTENDENT'S HOME front façade windows

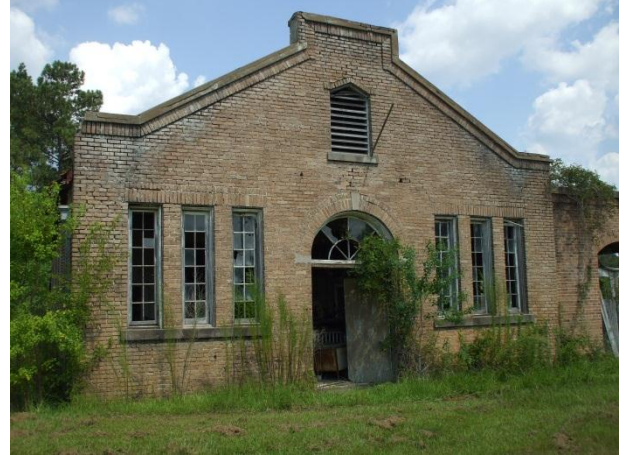
According to the MDAH GIS Map Viewer, this structure is not listed in the NRHP nor is it registered as a Mississippi Landmark. The structure is deteriorating because of lack of general maintenance but appears to remain structurally sound.

**PHOTO 47** – Front façade (west side) of LAUNDRY BUILDING

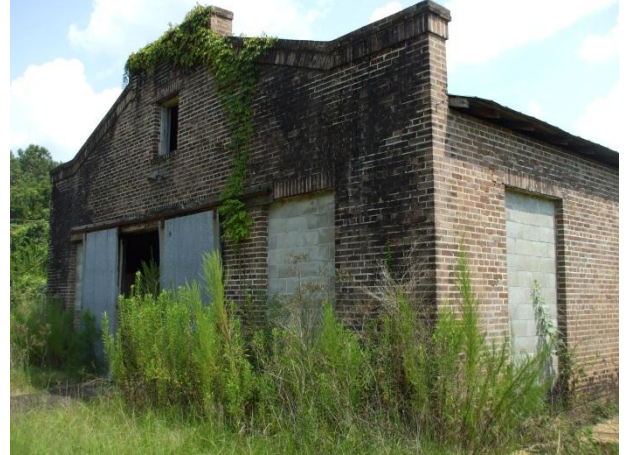
According to the MDAH GIS Map Viewer, this structure is not listed in the NRHP nor is it registered as a Mississippi Landmark. The structure is deteriorating because of lack of general maintenance but appears to remain structurally sound.

**PHOTO 51** – Front façade (north side) of POWER PLANT
