Wetland Delineation and Stream Assessment

(Triple Rail Site) – (McCracken County, KY)

July 2019

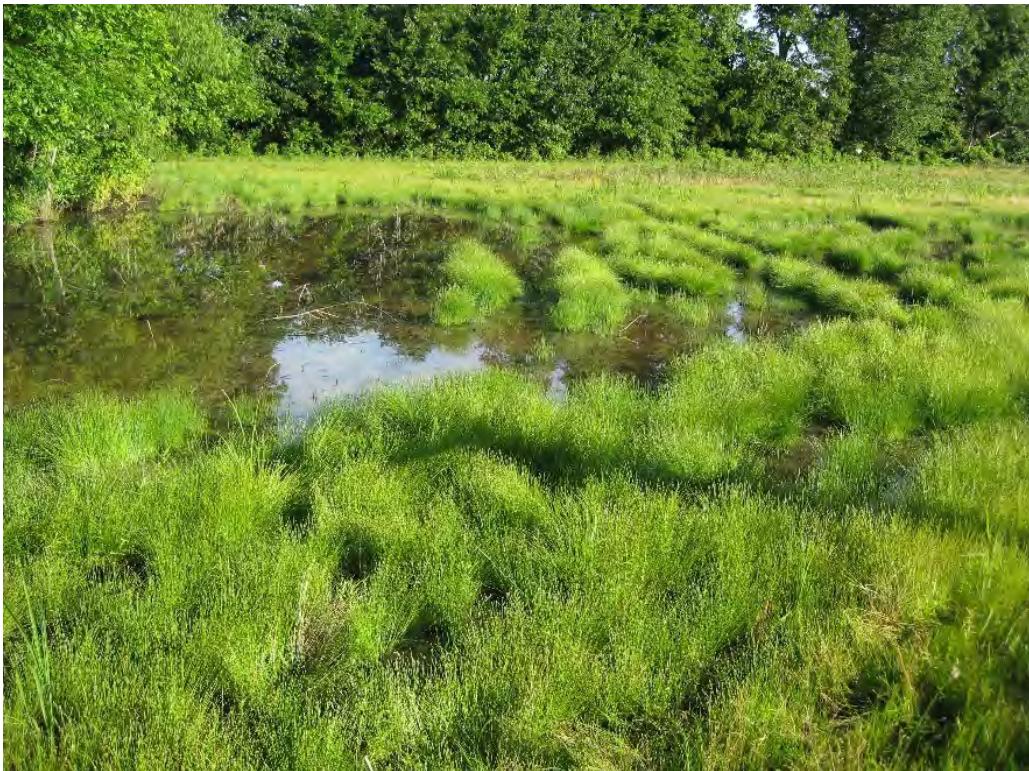
PEM1 is an emergent wetland has an area 0.37 acres and is connected directly to the eastern edge of a strip of forested area located in the northern portion of the project area. This area receives water from I6 when it overflows its banks during storm events. The area ponds water and does not drain. The dominant herbaceous stratum found within PEM1 consisted primarily of various herbaceous vegetation. The vegetation for

the data point taken within PEM1 indicated a dominant presence of hydrophytic vegetation. Additionally, various hydrologic indicators were observed within the soils. Soils have a silty-clay texture, with a matrix of 10YR 5/2 with redoximorphic features of 10YR 4/4 greater than 2% from 2 to 12 inches. These redoximorphic concentrations within the matrix are defined indicators of hydric soils. PEM1 has a distinctive dividing line between the wetland and upland which includes changes in plant communities, soils, and hydrologic characteristics. It lies within a farmed agricultural field.

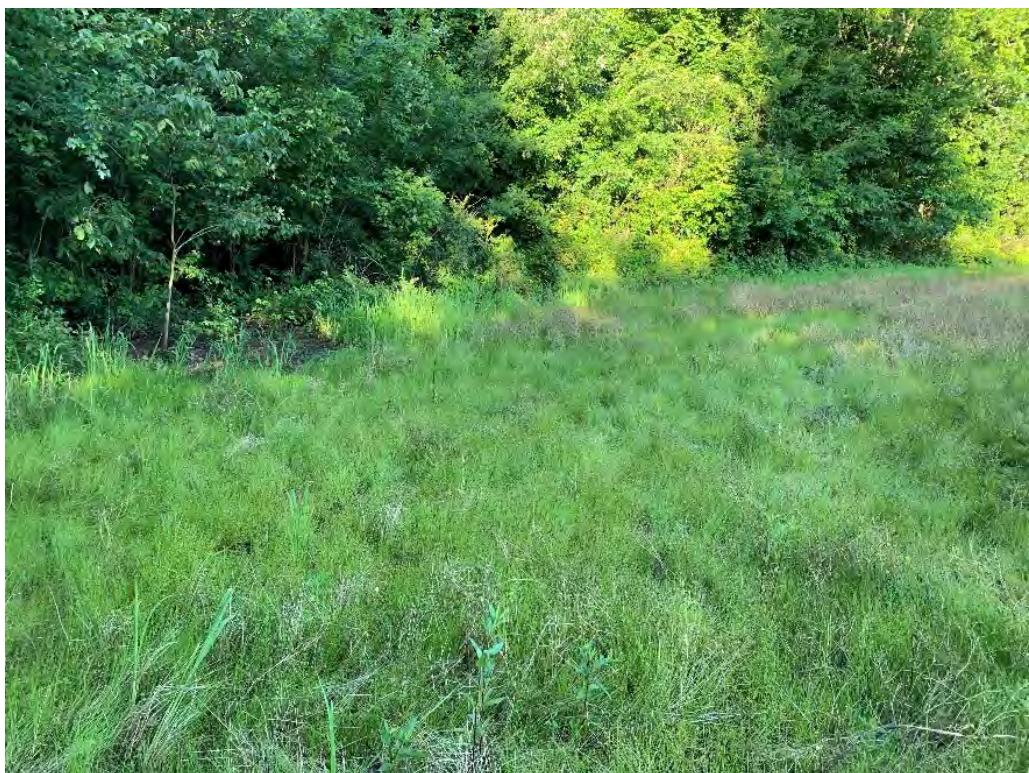
PEM2 is an emergent wetland has an area 0.21 acres and is connected directly to the northwestern edge of a forested area located in the northern portion of the project area. This area receives upland runoff from the adjacent farm field. The area ponds water and does not drain since it appears that trees and debris have been pushed into the edge of the woods and prevents the area from draining properly. The dominant herbaceous stratum found within PEM2 consisted primarily of various herbaceous vegetation. The vegetation for the data point taken within PEM1 indicated a dominant presence of hydrophytic vegetation. Additionally, various hydrologic indicators were observed within the soils. Soils have a silty-clay texture, with a matrix of 10YR 5/2 with redoximorphic features of 5YR 4/6 greater than 2% from 2 to 8 inches. These redoximorphic concentrations within the matrix are defined indicators of hydric soils. PEM2 has a distinctive dividing line between the wetland and upland which includes changes in plant communities, soils, and hydrologic characteristics. It lies within a farmed agricultural field.

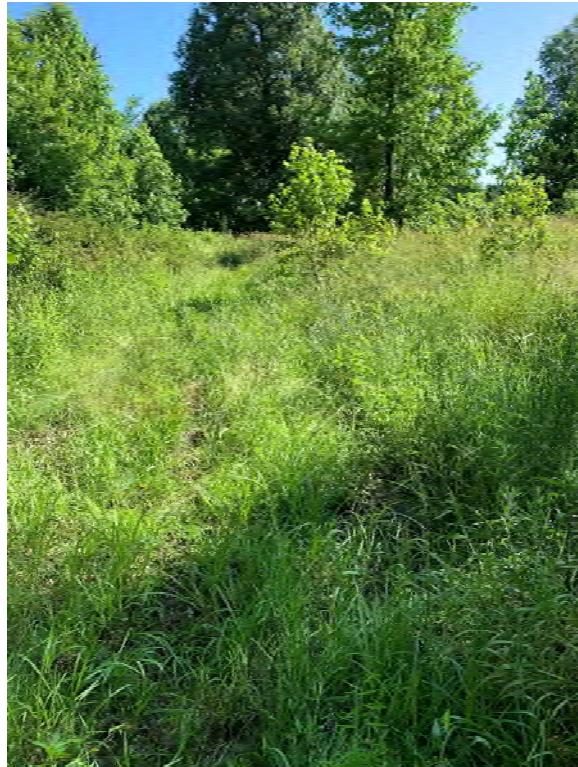
PEM3 is an emergent wetland has an area 0.83 acres and is connected directly to PFO1 wetland found in the wooded area to the west. This area receives upland runoff from the adjacent farm field as well as runoff from the roadside ditch located north and east of the area. The area ponds water and does not drain well. The dominant herbaceous stratum found within PEM2 consisted primarily of various herbaceous vegetation. The vegetation for the data point taken within PEM1 indicated a dominant presence of hydrophytic vegetation. Additionally, various hydrologic indicators were observed within the soils. Soils have a silty-clay texture, with a matrix of 10YR 6/1 with redoximorphic features of 5YR 4/3 greater than 2% from 3 to 12 inches. These redoximorphic concentrations within the matrix are defined indicators of hydric soils. PEM3 has a distinctive dividing line between the wetland and upland which includes changes in plant communities, soils, and hydrologic characteristics.

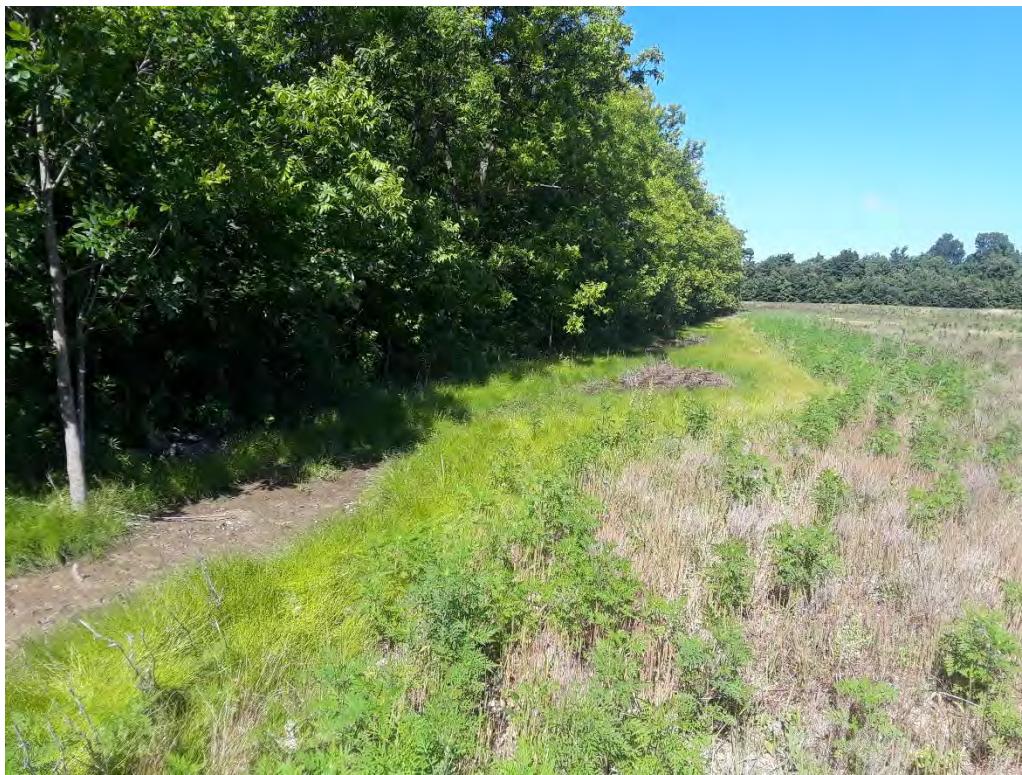
PEM4 is an emergent wetland has an area 0.38 acres and is isolated. This area receives upland runoff from the adjacent farm field. There is a rise in topography in the field and a rise in the wooded areas that the wetland lies adjacent which creates a bowl. The wooded area is composed of rows of pecan trees that were most likely planted by the previous resident. The area ponds water and does not drain well. The dominant herbaceous stratum found within PEM4 consisted primarily of various herbaceous vegetation. The vegetation for the data point taken within PEM4 indicated a dominant presence of hydrophytic vegetation. Additionally, various hydrologic indicators were observed within the soils. Soils have a silty-clay texture, with a matrix of 10YR 5/2 with redoximorphic features of 5YR 4/6 greater than 2% from 2 to 12 inches. These redoximorphic concentrations within the matrix are defined indicators of hydric soils. PEM4 has a distinctive dividing line between the wetland and upland which includes changes in plant communities, soils, and hydrologic characteristics.

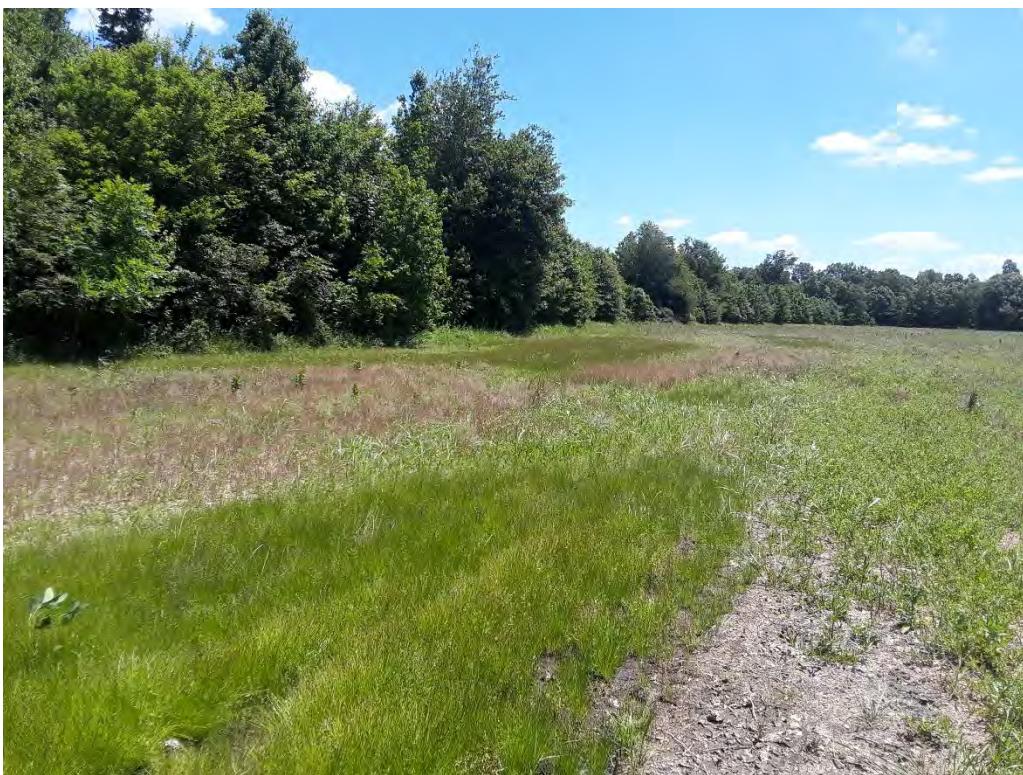
PEM6 is an emergent wetland has an area 0.18 acres and receives water from the adjacent farm field but is considered isolated. The area ponds water and does not drain well due to farming activities and possibly from the installation of a field tile. The dominant herbaceous stratum found within PEM6 consisted primarily of various herbaceous vegetation. The vegetation for the data point taken within PEM6 indicated a dominant presence of hydrophytic vegetation. Additionally, various hydrologic indicators were observed within the soils. Soils have a silty-clay texture, with a matrix of 10YR 5/2 with redoximorphic features of 5YR 4/6 greater than 2% from 2 to 12 inches. These redoximorphic concentrations within the matrix are defined indicators of hydric soils. PEM6 has a distinctive dividing line between the wetland and upland which includes changes in plant communities, soils, and hydrologic characteristics.

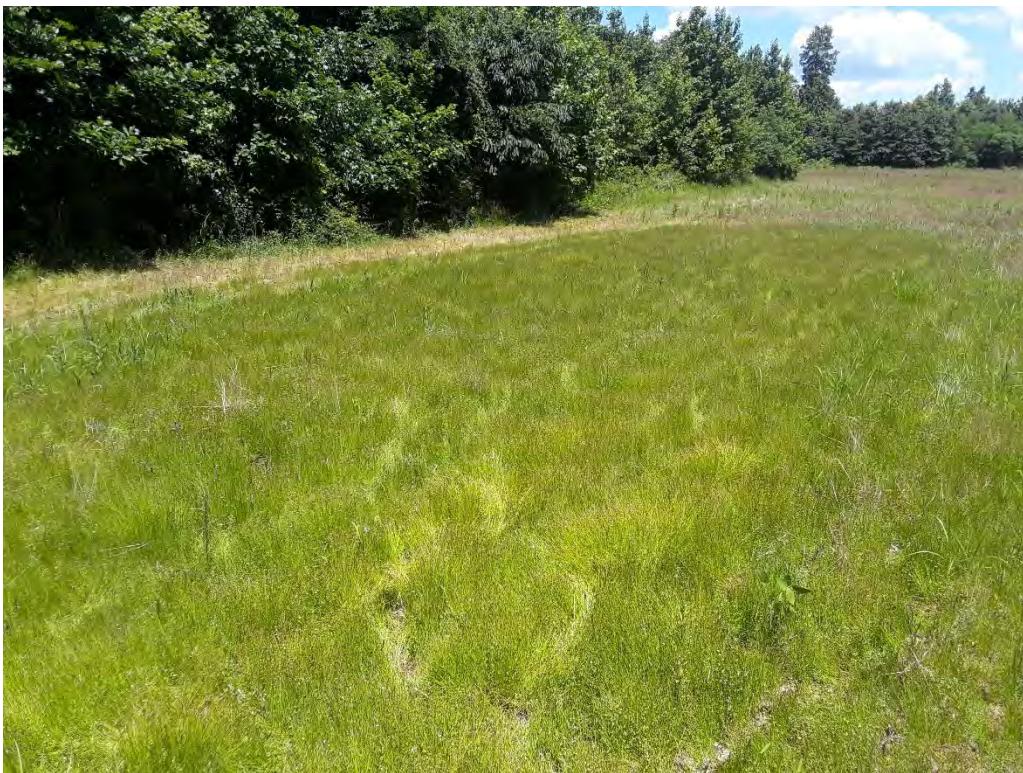
PEM7 is an emergent wetland has an area 0.11 acres and receives water from the adjacent farm field. The farmer has graded the field to drain to this area, enter the wooded area to the west, and has then dug a drainage ditch (E4) that he has routed to I4. The area ponds water and does not drain well. The dominant herbaceous stratum found within PEM7 consisted primarily of various herbaceous vegetation. The vegetation for the data point taken within PEM7 indicated a dominant presence of hydrophytic vegetation. Additionally, various hydrologic indicators were observed within the soils. Soils have a silty-clay texture, with a matrix of 10YR 5/2 with redoximorphic features of 5YR 4/4 greater than 2% from 2 to 12 inches. These redoximorphic concentrations within the matrix are defined indicators of hydric soils. PEM7 has a distinctive dividing line between the wetland and upland which includes changes in plant communities, soils, and hydrologic characteristics.

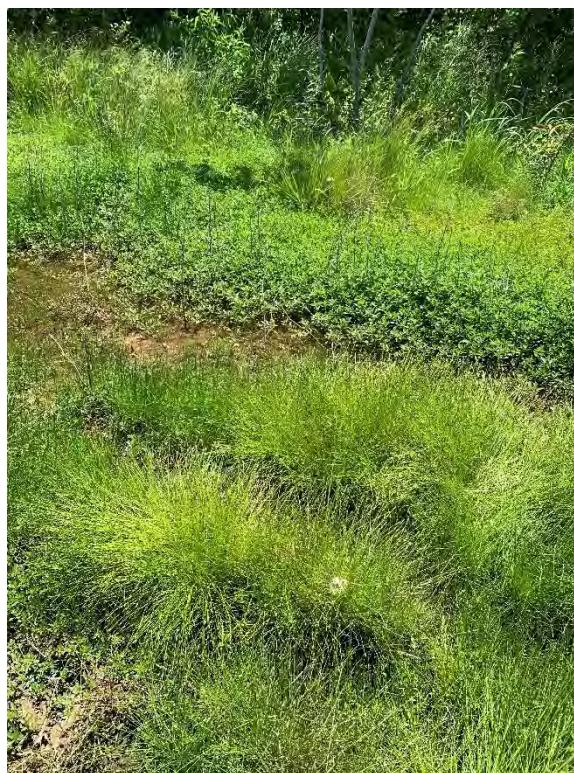
PEM8 is an emergent wetland has an area 0.20 acres and receives water from the adjacent farm field. The farmer has graded the field to drain to this area, which then enters E5 and drains to I4. The area ponds water and does not drain well. The dominant herbaceous stratum found within PEM8 consisted primarily of various herbaceous vegetation. The vegetation for the data point taken within PEM8 indicated a dominant presence of hydrophytic vegetation. Additionally, various hydrologic indicators were observed within the soils. Soils have a silty-clay texture, with a matrix of 10YR 6/2 with redoximorphic features of 5YR 5/8 greater than 2% from 2 to 12 inches. These redoximorphic concentrations within the matrix are defined indicators of hydric soils. PEM8 has a distinctive dividing line between the wetland and upland which includes changes in plant communities, soils, and hydrologic characteristics.

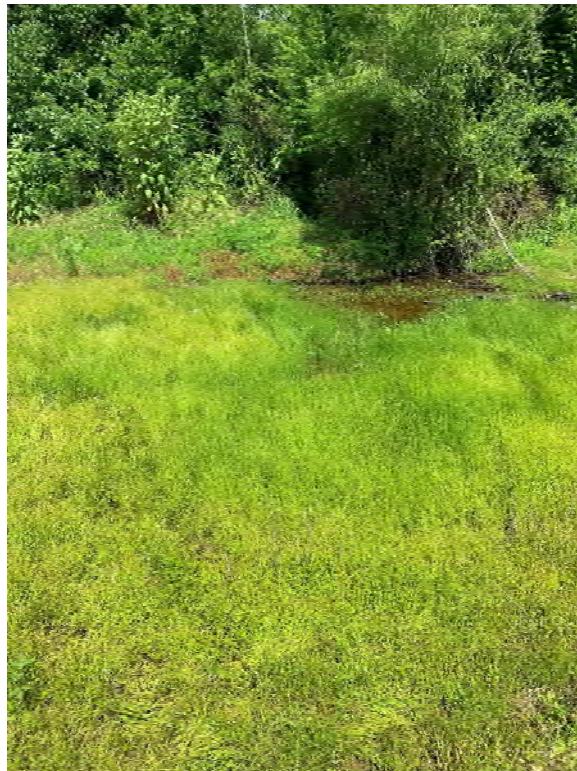
PEM9 is an emergent wetland has an area 0.05 acres and is considered isolated. This is a low depressional area adjacent to the woods that ponds water because debris has been pushed into the woods by the farmer. The area ponds water and does not drain well. The dominant herbaceous stratum found within PEM9 consisted primarily of various herbaceous vegetation. The vegetation for the data point taken within PEM9 indicated a dominant presence of hydrophytic vegetation. Additionally, various

hydrologic indicators were observed within the soils. Soils have a silty-clay texture, with a matrix of 10YR 6/1 with redoximorphic features of 5YR 5/8 greater than 2% from 2 to 12 inches. These redoximorphic concentrations within the matrix are defined indicators of hydric soils. PEM9 has a distinctive dividing line between the wetland and upland which includes changes in plant communities, soils, and hydrologic characteristics.

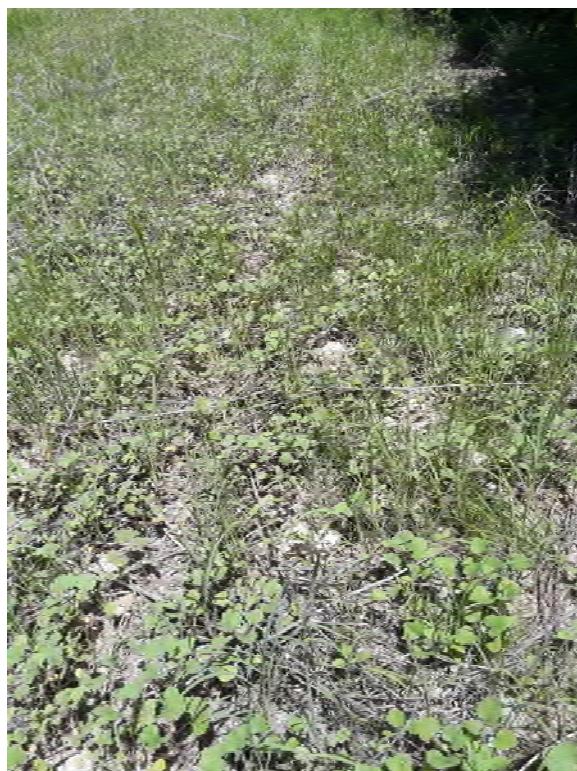
PEM10 is an emergent wetland has an area 0.28 acres and receives water from the adjacent farm field as well as overflow from I2. This is a low depressional area adjacent to the woods that ponds water and then enters the wooded area to form PFO5. The area ponds water and does not drain well. The dominant herbaceous stratum found within PEM10 consisted primarily of various herbaceous vegetation. The vegetation for the data point taken within PEM9 indicated a dominant presence of hydrophytic vegetation. Additionally, various hydrologic indicators were observed within the soils. Soils have a silty-clay texture, with a matrix of 10YR 6/1 with redoximorphic features of 5YR 5/8 greater than 2% from 2 to 12 inches. These redoximorphic concentrations within the matrix are defined indicators of hydric soils. PEM10 has a distinctive dividing line between the wetland and upland which includes changes in plant communities, soils, and hydrologic characteristics.

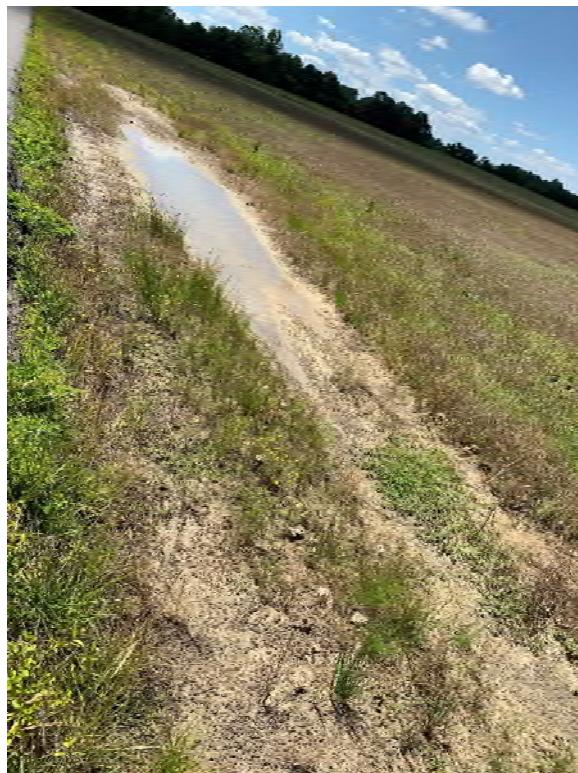
PEM11 is an emergent wetland has an area 0.22 acres and receives water from the adjacent farm field as well as overflow from I3. This is a low depressional area located in the southern portion of the property that lies adjacent to Bobo Road. The area ponds water and does not drain well. The dominant herbaceous stratum found within PEM11 consisted primarily of various herbaceous vegetation. The vegetation for the data point taken within PEM11 indicated a dominant presence of hydrophytic vegetation. Additionally, various hydrologic indicators were observed within the soils. Soils have a silty-clay texture, with a matrix of 10YR 6/1 with redoximorphic features of 5YR 5/8 greater than 2% from 2 to 12 inches. These redoximorphic concentrations within the matrix are defined indicators of hydric soils. PEM11 has a distinctive dividing line between the wetland and upland which includes changes in plant communities, soils, and hydrologic characteristics.

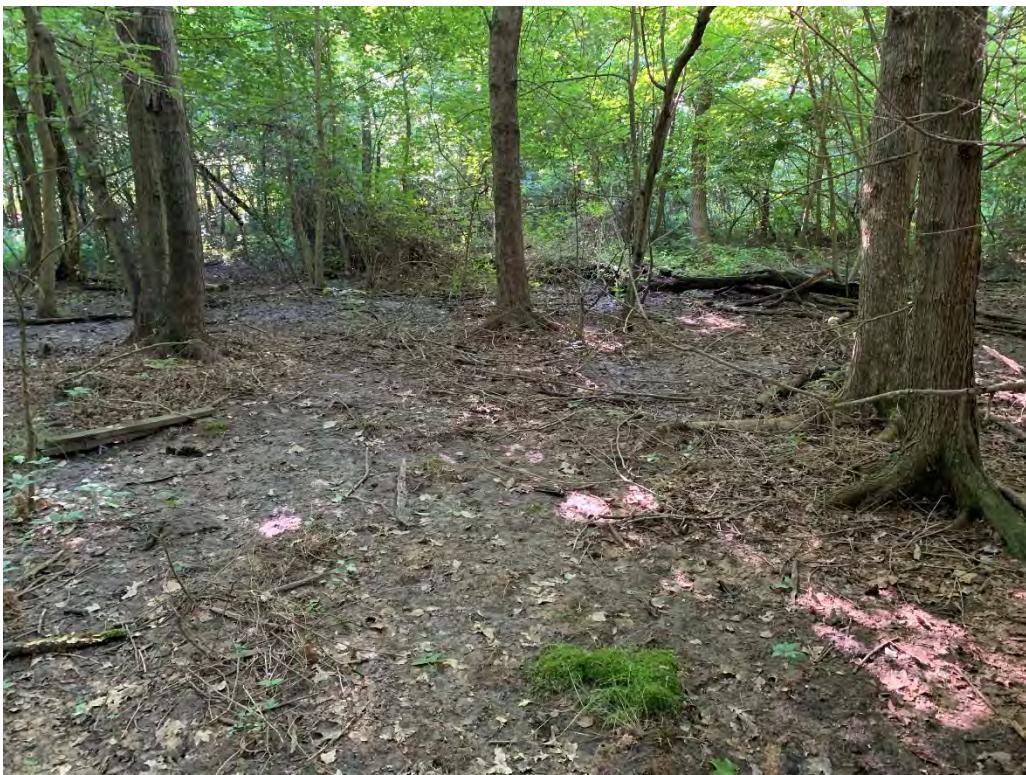
PFO1 is a forested wetland has an area of 2.03 acres and is connected to PEM3. Prior clearing and storm damage has resulted in the creation of a wet ponded areas within these woods. The area receives inundation from stormwater events. The dominant vegetation is primarily comprised of hickory, pin oak, jewelweed, and boneset. Various hydrologic indicators were observed within the soils. Soils have a silty-loam texture, with a matrix of 10YR 5/1 with redoximorphic features of 10YR 4/6 greater than 2% from 3 to 10 inches. These redoximorphic concentrations within the matrix are defined indicators of hydric soils.

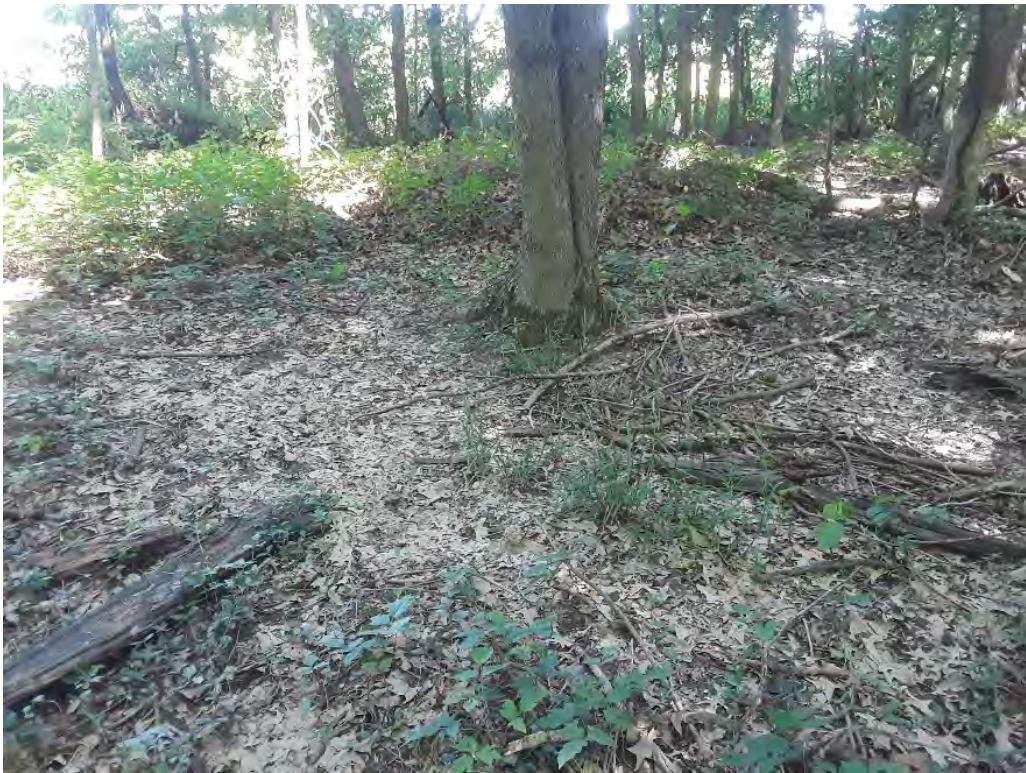
PFO2 is a forested wetland has an area of 0.40 acres and receives overflow from I6. The area receives inundation from stormwater events. The dominant vegetation is primarily comprised of hickory, pin oak, jewelweed, and small spike false nettle. Various hydrologic indicators were observed within the soils. Soils have a silty-loam texture, with a matrix of 10YR 5/1 with redoximorphic features of 10YR 4/6 greater than 2% from 3 to 6 inches. These redoximorphic concentrations within the matrix are defined indicators of hydric soils.

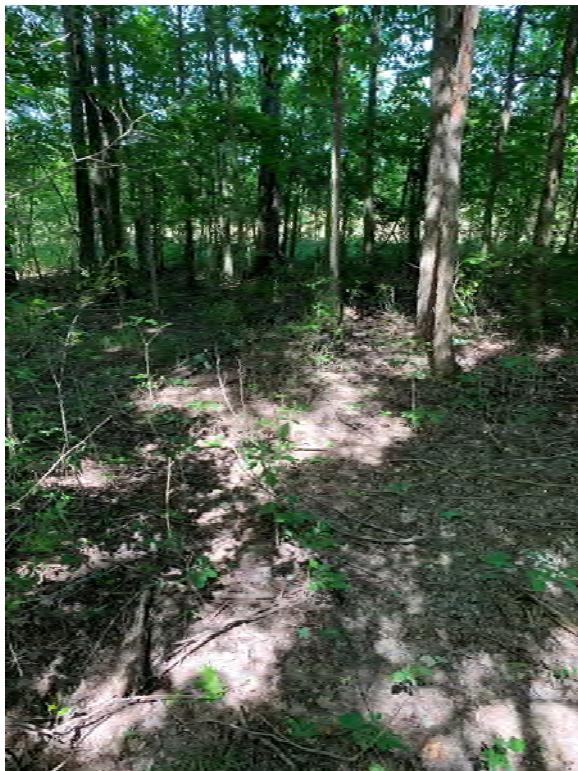
PFO3 is a forested wetland has an area of 0.28 acres and lies in the wooded areas located north of PEM6. This is a depressional area located in the wooded area that ponds water after storm events. The dominant vegetation is primarily comprised of red maples. Various hydrologic indicators were observed within the soils. Soils have a silty-

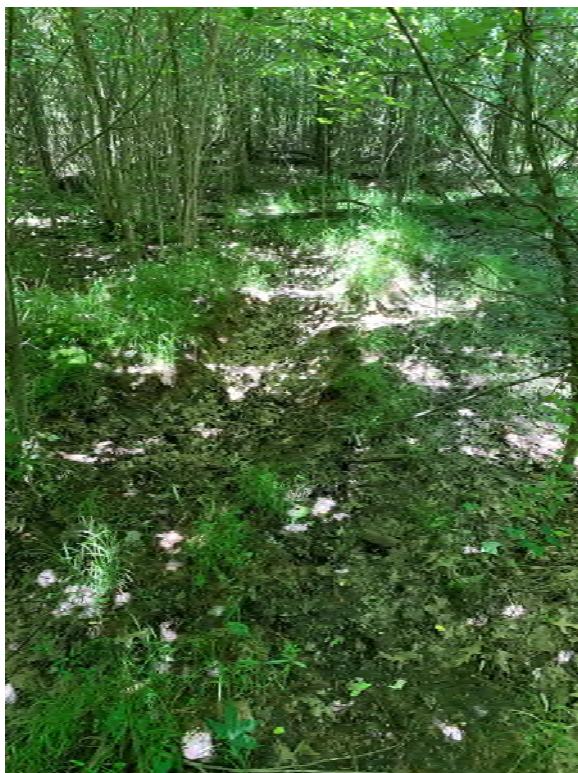
PFO4 is a forested wetland has an area of 0.43 acres and is connected to E4. Prior clearing and storm damage has resulted in the creation of a wet ponded areas within these woods. E4 was channelized to carry the water from the site to I4. This wetland is located to the west of this conveyance and ponds water after storm events. Large tire tracks indicated that prior clearing activities probably occurred here. The dominant vegetation is primarily comprised of red maple, pin oak, and honeysuckle. Various hydrologic indicators were observed within the soils. Soils have a silty-loam texture, with a matrix of 10YR 5/2 with redoximorphic features of 10YR 4/4 greater than 2% from 3 to 10 inches. These redoximorphic concentrations within the matrix are defined indicators of hydric soils.

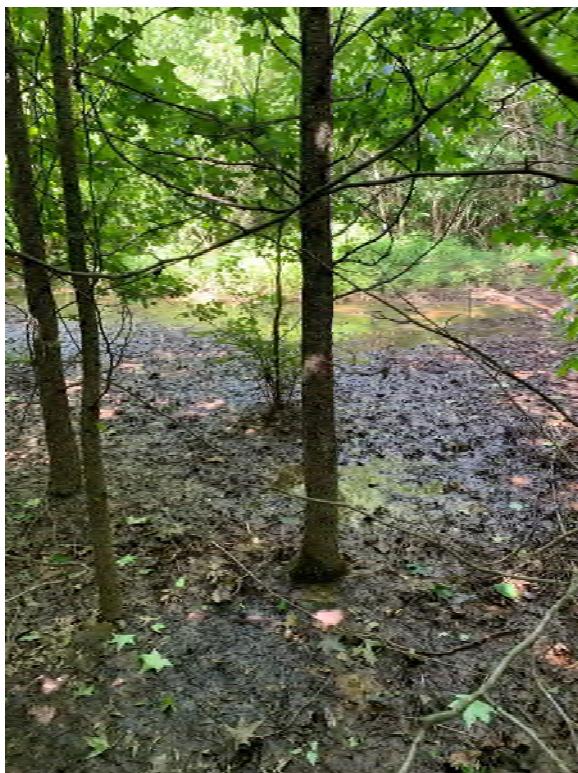
PFO5 is a forested wetland has an area of 0.43 acres and is connected to PEM10 and E3. Prior clearing and storm damage has resulted in the creation of a wet ponded areas within these woods. Water quickly leaves the banks of E3 and ponds in these flat areas as well. The area receives inundation from stormwater events and most likely receives water from I2 overflowing as well. The dominant vegetation is primarily comprised of hickory, pin oak, red maple, and jewelweed. Various hydrologic indicators were observed within the soils. Soils have a silty-clay texture, with a matrix of 10YR 5/1 with redoximorphic features of 10YR 5/8 greater than 2% from 3 to 6 inches. These redoximorphic concentrations within the matrix are defined indicators of hydric soils.

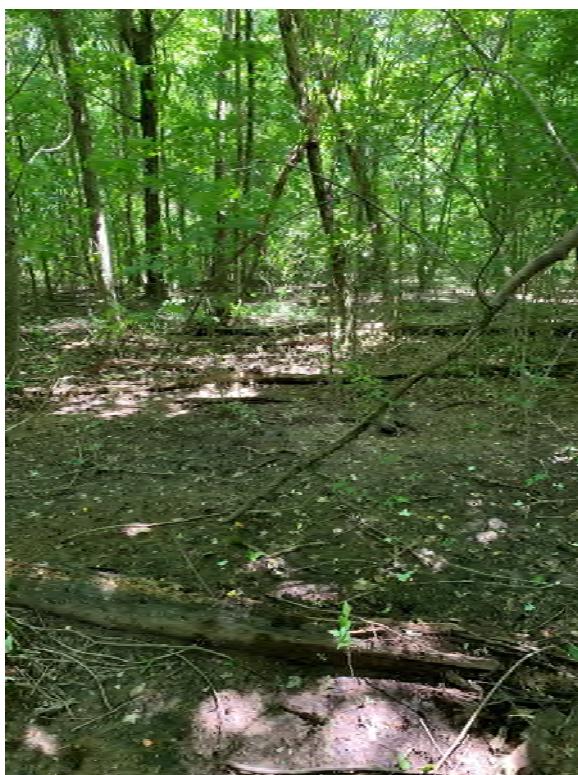
PFO6 is a forested wetland has an area of 1.38 acres and is connected to E3. Prior clearing and storm damage has resulted in the creation of a wet ponded areas within these woods. The area receives inundation from stormwater events when E3 overflows its banks. The dominant vegetation is primarily comprised of elm, sweet gum, pin oak, jewelweed, virginia creeper, and poison ivy. Various hydrologic indicators were observed within the soils. Soils have a silty-clay texture, with a matrix of 10YR 6/1 with redoximorphic features of 10YR 4/6 greater than 2% from 4 to 12 inches. These redoximorphic concentrations within the matrix are defined indicators of hydric soils.

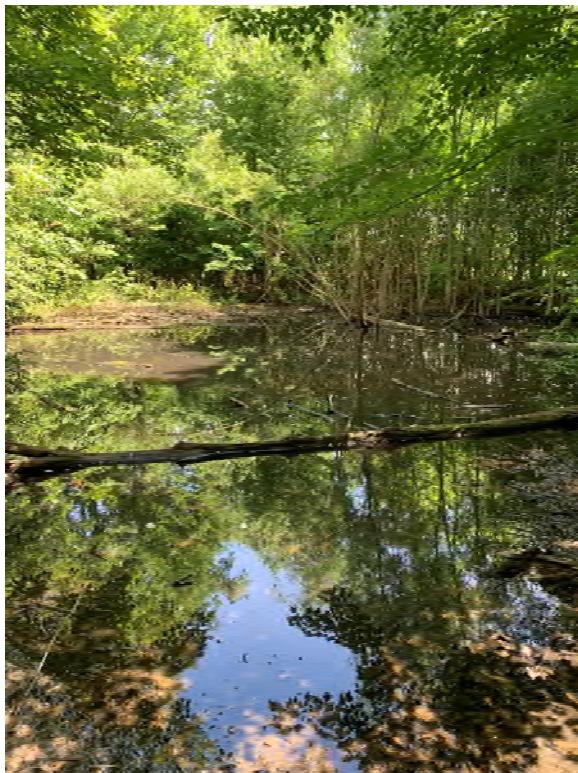
PFO7 is a forested wetland has an area of 0.31 acres and is connected to E2. This area receives stormwater runoff from I2 and from the adjacent farm field. The dominant vegetation is primarily comprised of red maple, willow, and poison ivy. Various hydrologic indicators were observed within the soils. Soils have a silty-clay texture, with a matrix of 10YR 6/1 with redoximorphic features of 10YR 4/6 greater than 2% from 0 to 12 inches. These redoximorphic concentrations within the matrix are defined indicators of hydric soils.

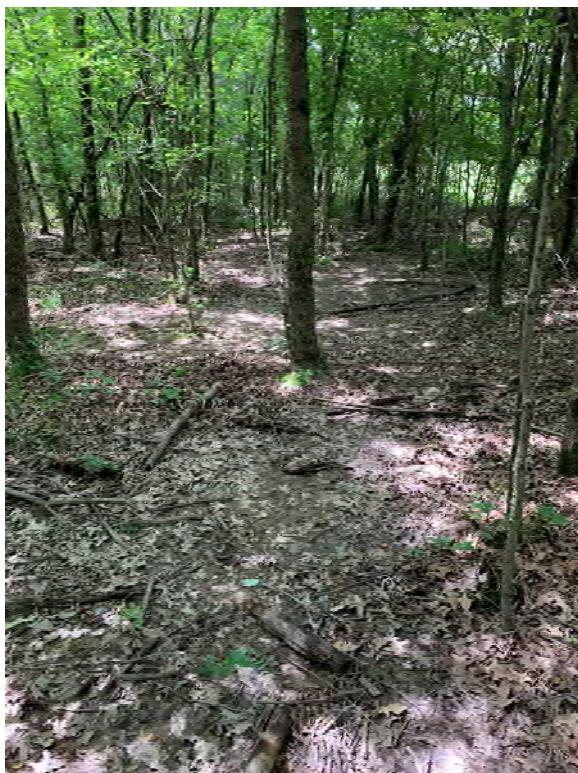
PFO8 is a forested wetland has an area of 0.24 acres and lies adjacent to I4. This area receives stormwater runoff from the adjacent farm field. The dominant vegetation is primarily comprised of red maple, elm, and virginia creeper. Various hydrologic indicators were observed within the soils. Soils have a silty-loam texture, with a matrix of 10YR 5/2 with redoximorphic features of 10YR 4/6 greater than 2% from 0 to 10 inches. These redoximorphic concentrations within the matrix are defined indicators of hydric soils.

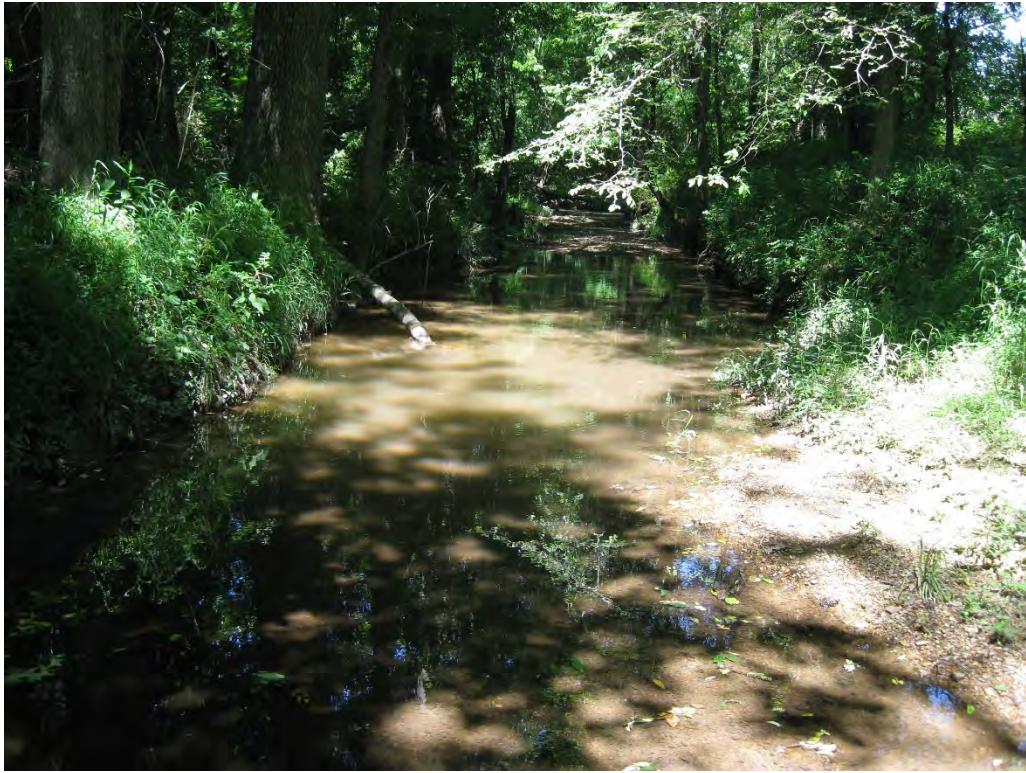
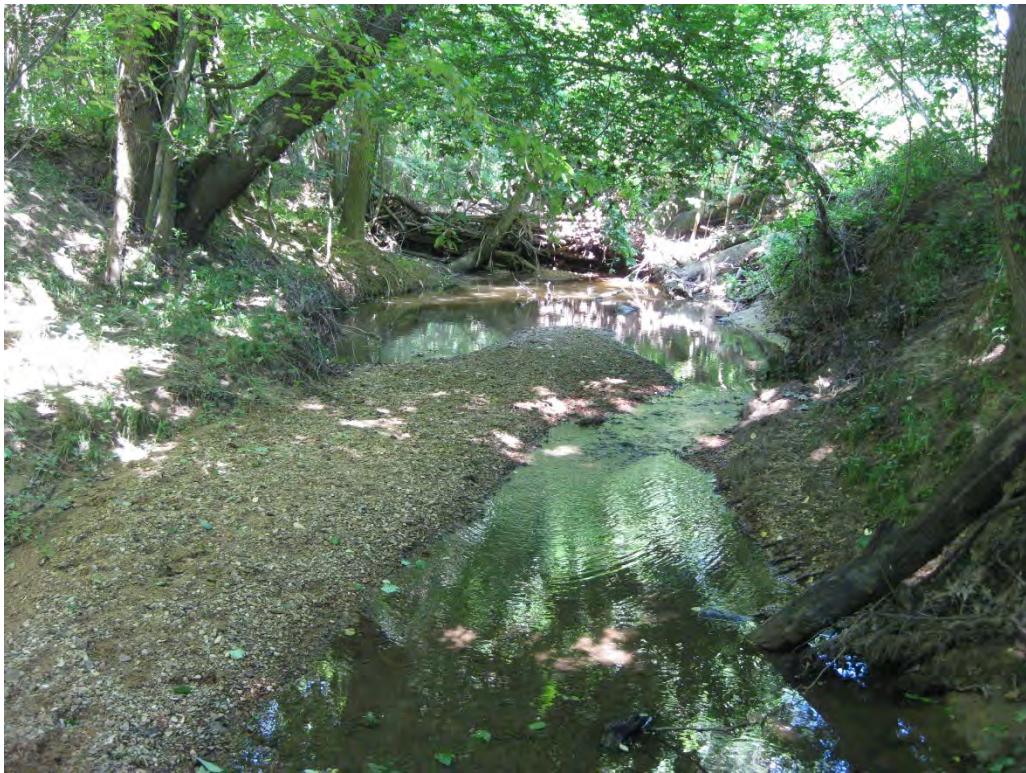
I1-US

Intermittent Stream 1 (I1) is located in the southern section of the study area, flowing east for 1,666 feet. It should be noted that this length only reflects what is located within the study area. This creek is not labeled on USGS topographic maps but is an unnamed tributary to Massac Creek. Due to its length, two (2) assessments were performed. The stream has an average bottom width of 12 feet and an average bankfull width of 17 feet.

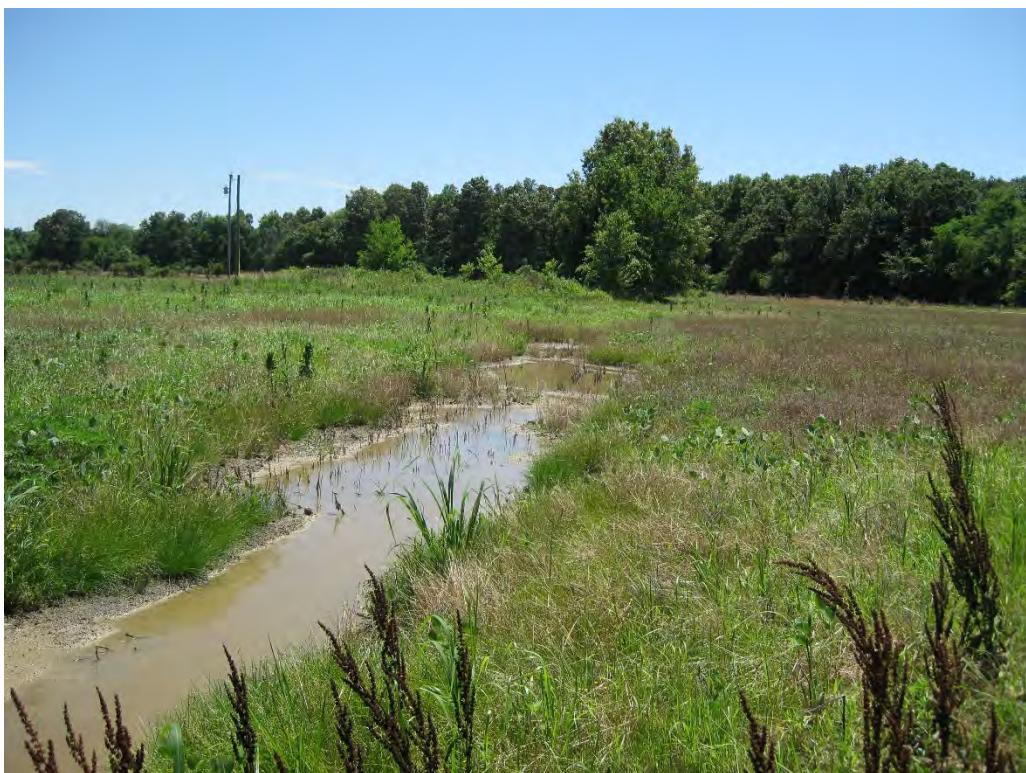
I3-US

The stream habitat assessment (Low Gradient) for the upstream reach (I3-US) indicates the epifaunal substrate/available cover score is in the poor range since there was a very obvious lack of habitat. Streambed morphology consists of mostly runs, with few pools; with the majority of the pools present being shallow. The stream substrate consists of silt/clay size material only. Heavy deposition of fine sediment is present, with more than 80 percent of the bottom changing frequently. There is evidence of channelization, and sinuosity scored poor. During the assessment, the only water found in the channel was in a few pooled areas. The banks were moderately unstable (marginal score) with 30-60 percent of erosional area. This is due to only having herbaceous and grass vegetation. Vegetative protection scored as marginal, and the riparian width was poor due to previous farming activities.
