**Cultural Resource Survey**

374 Acres (+/-) in Marion County, Mississippi  
Columbia North USGS Quadrangle Map  
Sections 34 & 35, Township 4N, Range 18W  
Gulf South Project Number DUN1-12-004

December 10, 2012

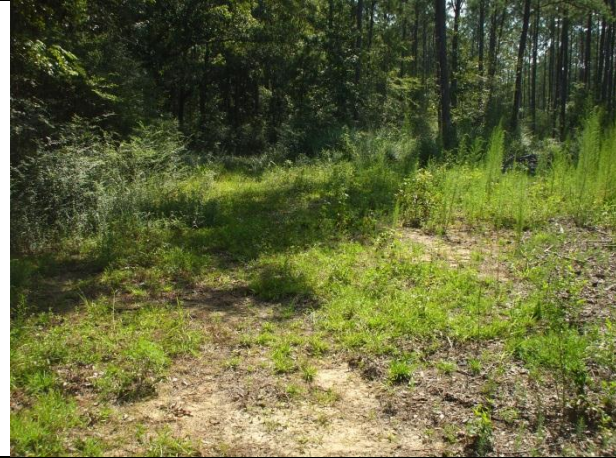
**PHOTO 14** – Photo taken facing east from the datum of site number 22Ma800, where three flakes were identified on the surface. All subsurface shovel tests in this area did not yield artifacts.

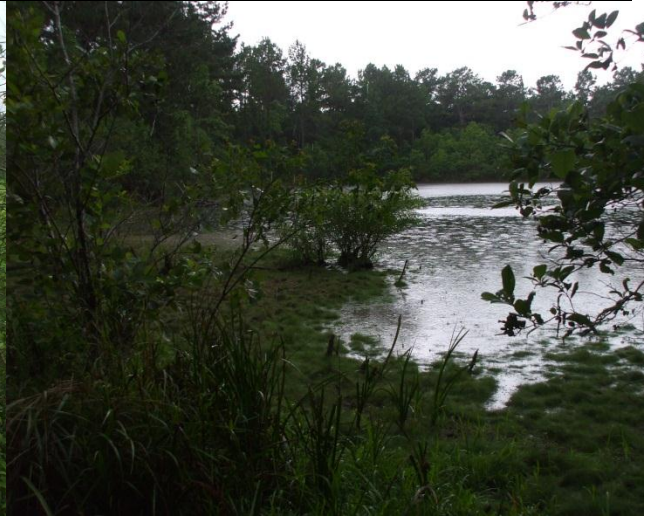
**PHOTO 19** – Manmade pond in northeast quadrant of survey property, facing south.

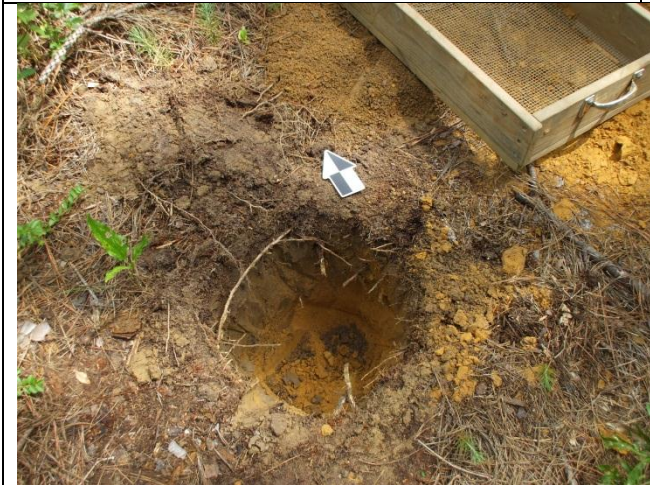
The subsoil in upland areas that was typically encountered ranged from orange clay (Photo 20) to dark brown “hardpan” loam (Photo 21). Shovel tests in the bottomland hardwood areas were typically terminated due to wet clay and loam, when water entered the test pit, or when other natural disturbances such as stream sediment materials or thick tree roots were encountered.

**PHOTO 20** – Shovel test unearthing typical yellowish-orange clayey subsoil encountered on the survey property.

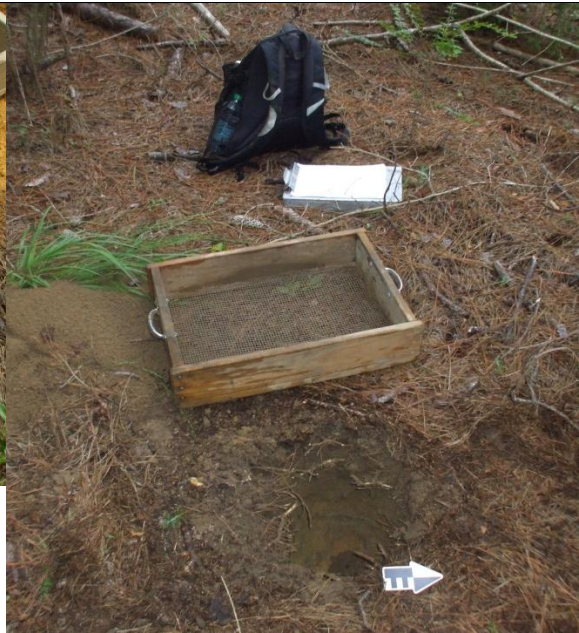
**PHOTO 21** – Shovel test unearthing typical brownish hardpan subsoil encountered on the survey property.

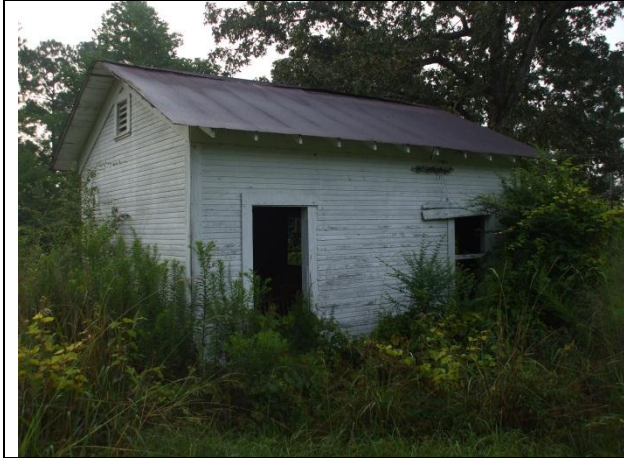
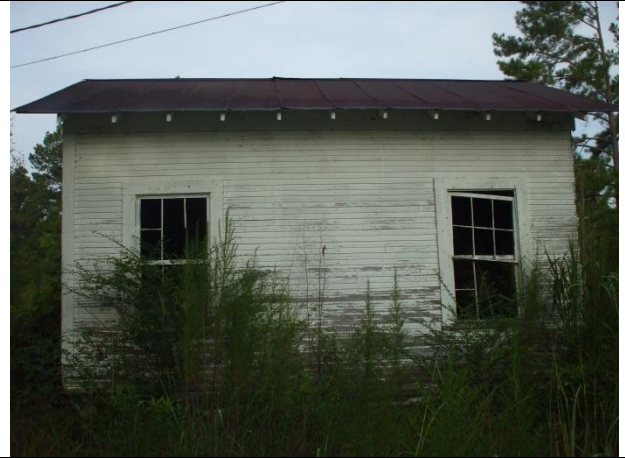
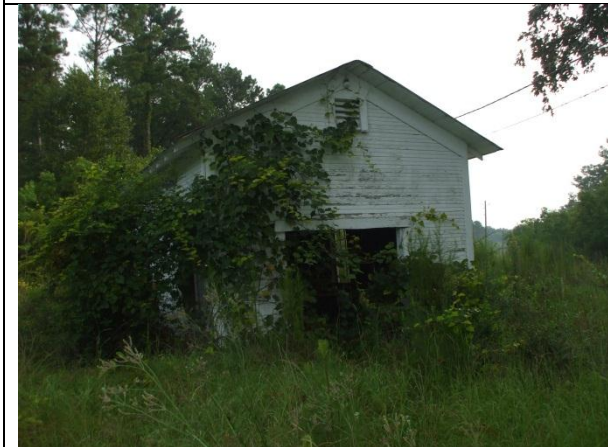
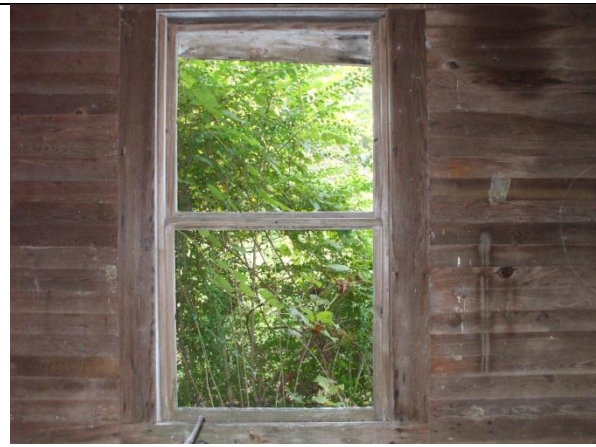
**Newly Recorded Outbuilding**

6. **Outbuilding** – This is a wood frame outbuilding (Photos 22-25) that was probably constructed in the 1920's or 1930's. This structure is located off the gravel drive just west of Lake Victoria at N31.26222° W89.80160° (NAD27). It once served as an outbuilding to a CTS staff house that burned to the ground a number of years ago (Communication with James Culliver). According to the MDAH Map Viewer, the associated destroyed house was not part of the MDAH Inventory system at the CTS property and it is not known if the structure was ever documented.

The extant outbuilding is approximately 16' x 21' and includes a bay door opening, a damaged concrete foundation, tin roof, and wood siding. The interior walls and ceiling are constructed with wood as well. No door remains on the bay opening and the window glass does not remain. Based on the damaged foundation, it is not believed that this building is structurally sound.

Discarded fifty-gallon drums were observed inside the outbuilding and situated on wooden grates on the floor. It is not known if substances that were once contained in the drums were

**PHOTO 22** – Northwest side of Outbuilding

**PHOTO 23** – West side of Outbuilding

**PHOTO 24** – Front (south) façade of Outbuilding

**PHOTO 25** – Interior side of window of Outbuilding

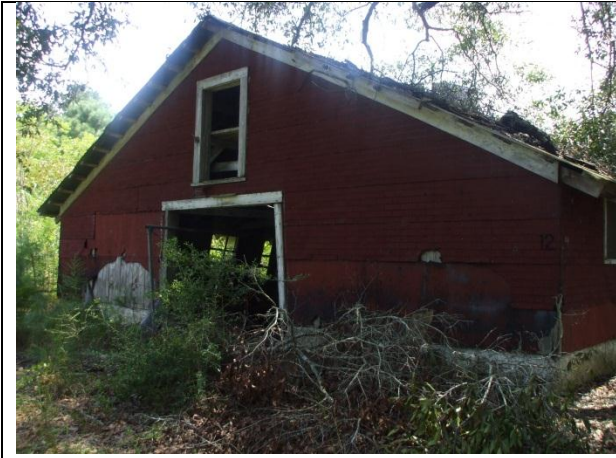
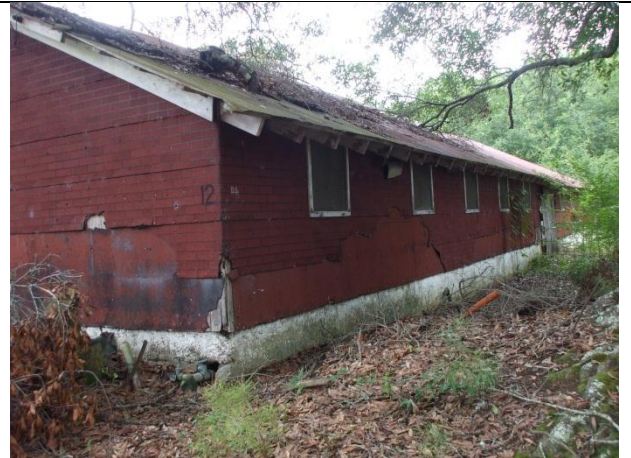
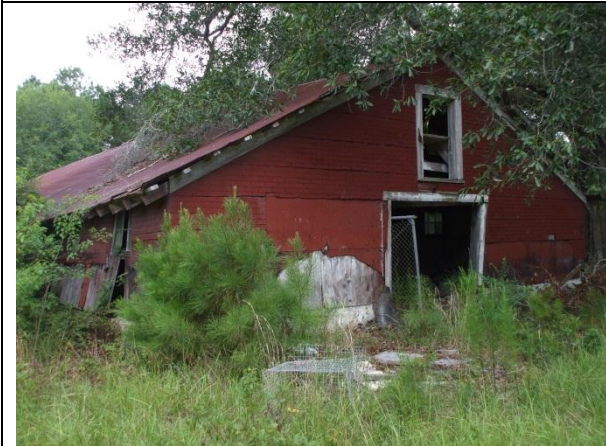
**Newly Recorded Dairy Barn**

The building is a wood frame rectangular structure measuring approximately 32' x 115' and has a concrete foundation, metal roof and faux brick asphalt siding, which was probably added in the 1960's (communication with James Culliver). Portions of the interior were inspected during the site visit. Discarded tires, trash, and a 50-gallon drum were observed inside the barn (Photo 29). Waste products from the cattle and potentially hazardous byproducts of historic livestock management activities may remain in the barn and surrounding soil and ground water. The barn has deteriorated over the years and remains in disrepair (Photos 26-28).

**PHOTO 26** – Dairy Barn front façade (north side)

**PHOTO 27** – West side of the Dairy Barn

**PHOTO 28** – Dairy Barn front façade (north side)

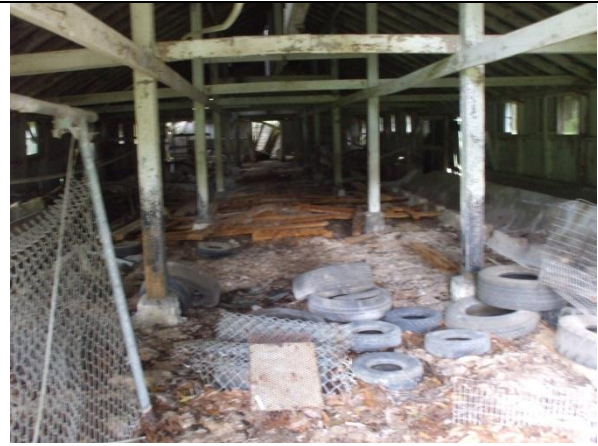
**PHOTO 29** – Interior of the Dairy Barn

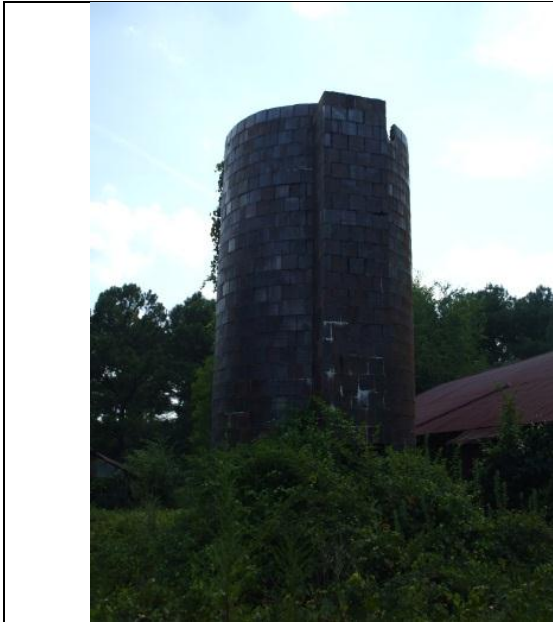
- 2. Silo associated with the Dairy Barn** – A silo is located just east of the dairy barn (Photo 30). The silo was used to store grain as part of the livestock activities at the CTS prior to the 1980's. The silo is not clearly visible on the 1952 aerial photograph of the property (Photo 01). The current location of the silo appears to be a square structure in the 1968 aerial photograph. This

**PHOTO 30** – Silo associated with the Dairy Barn

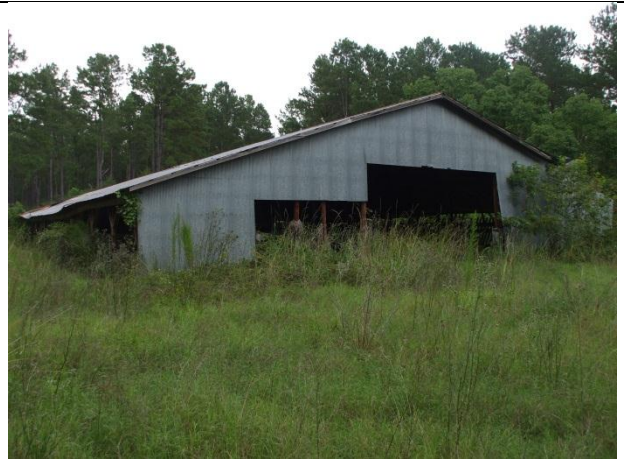
5. **Metal Barn** – This metal barn was probably built in the late 1970's and is currently used to store old tires (Photo 31). Other modern trash was observed inside the structure and it appears that some livestock could have been housed there as well. The barn remains intact at its original location: N31.26587° W89.79676° (NAD27). The structure is not eligible for the NRHP.

**PHOTO 31** – Metal Barn front (east) façade

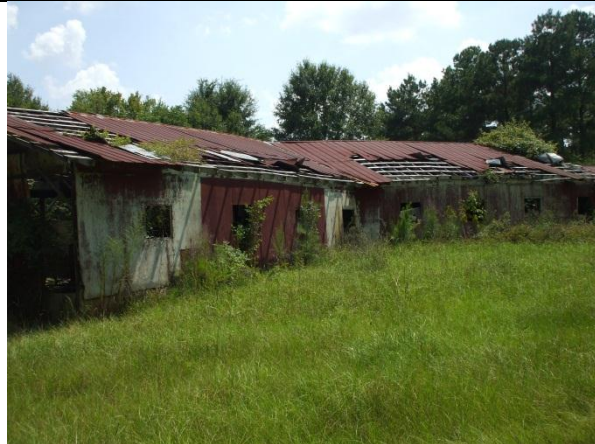
4. **Hog Production Barn** – The hog production barn is a wood frame structure that was in use for approximately 60 years (1920's – 1980's). The Hog Barn is located at N31.26573° W89.79549° (NAD27). The hog barn has a concrete foundation and metal roof. It is currently a dilapidated, V-shaped structure that sits in disrepair (Photo 32). Based on the 1968 aerial photo of the Property (Photo 03), it appears that the barn was originally linear, but a wing on the eastern end of the structure was added sometime after 1968. Limited portions of the interior were observed but could not be fully accessed due to the unsafe condition of the structure.

**PHOTO 32** – Hog production barn front façade

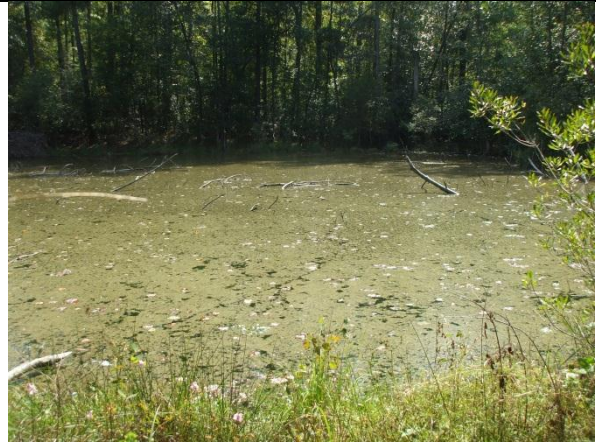
7. **Cistern** – A concrete-lined cistern was identified and observed during the field survey (See Photo 33) at GPS location N31.26574° W89.79115° (NAD27). The spring-fed cistern is surrounded by thick underbrush and measures approximately 125 by 60 feet. The cistern once served as part of the source of the onsite water system that serviced the CTS. The water in the cistern was stagnant during the site visit, a significant amount of algae was observed, and a noticeable foul odor was associated with the cistern. The cistern is downslope from part of the managed timber area and could contain runoff from that area and previous farming and livestock activities.

**PHOTO 33** – The concrete-lined cistern has not been in use for a number of decades

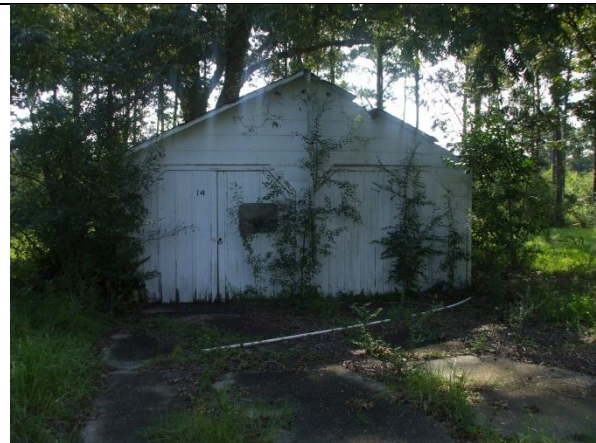
**PHOTO 45** – SUPERINTENDENT'S HOME garage in rear of home. This structure appears to have asbestos siding.

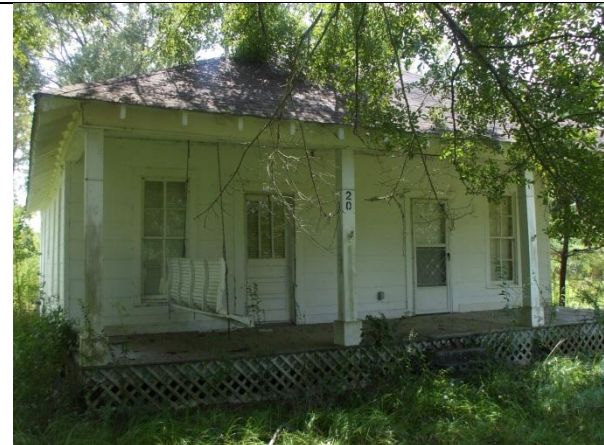
4. **091-COL-1209: "Staff House"** – This wood frame home was constructed in the American Prairie style with a hipped roof and a front porch that extends the width of the house (Photo 56). It features concrete shingles and siding that likely contains asbestos. There are two front door entrances and the house may have been modified over the years. An unattached wooden pavilion was added in the rear in recent years and was probably used as a carport. According to Mr. James Culliver, this house remained occupied in more recent years prior to the closure of the CTS in 2008.

**PHOTO 56** – MDAH Inventory Number 091-COL-1209 “Staff House” – front (west) façade

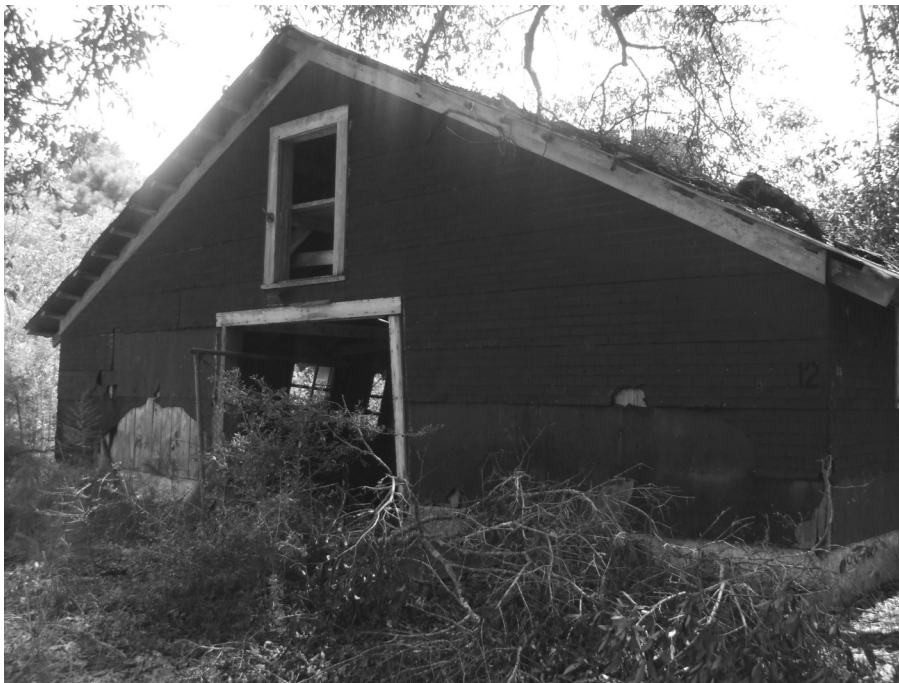
8. Brief description  The barn is a wood frame rectangular structure measuring 32 x 115 ft. and has a concrete foundation, metal roof and faux brick asphalt siding, which was added sometime after the original construction. Portions of the interior were observed during the site visit and old tires, trash, and a 50-gallon drum were observed inside the barn.  The rafters reveal the wood frame construction.		17. Date of construction  <input checked="" type="checkbox"/> estimated 1920's <input type="checkbox"/> documented

9. Outbuildings or secondary elements (if significant, use separate form) Silo; Metal Shed		18. Integrity  <input type="checkbox"/> very intact <input checked="" type="checkbox"/> deteriorated <input type="checkbox"/> some changes <input type="checkbox"/> ruins <input type="checkbox"/> extensive changes <input type="checkbox"/> no visible remains

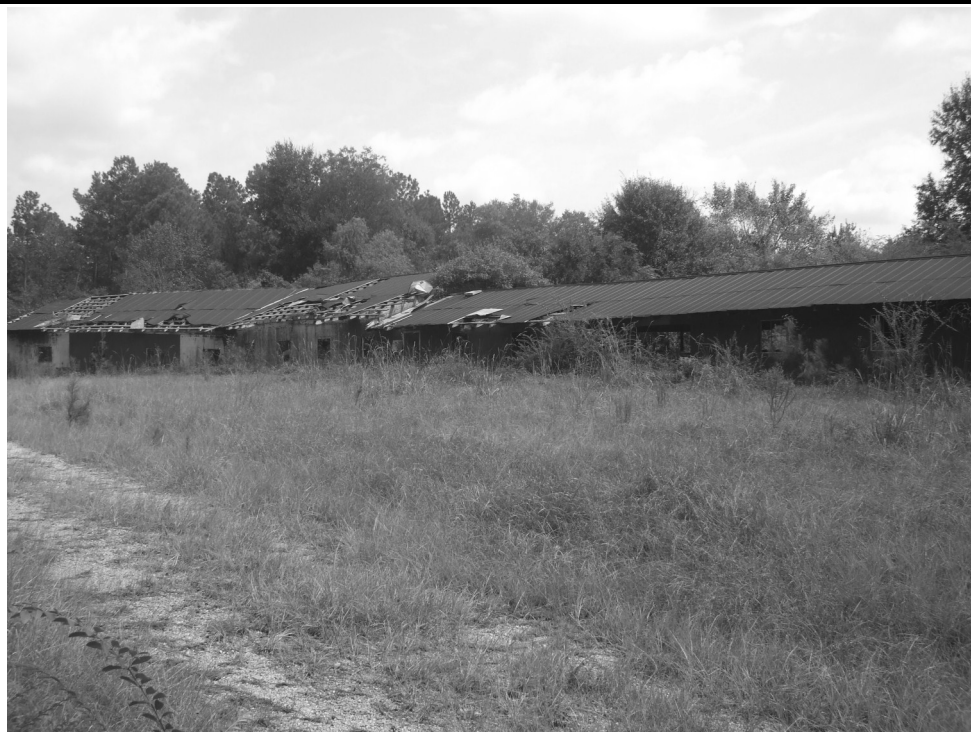
8. Brief description  The hog production barn is a wood frame structure with a metal roof and concrete foundation. Portions of the interior were observed but could not be fully accessed due to the unsafe condition of the structure.		17. Date of construction  <input checked="" type="checkbox"/> estimated      1920's <input type="checkbox"/> documented

9. Outbuildings or secondary elements (if significant, use separate form)  N/A		18. Integrity  <input type="checkbox"/> very intact <input checked="" type="checkbox"/> deteriorated <input type="checkbox"/> some changes <input type="checkbox"/> ruins <input type="checkbox"/> extensive changes <input type="checkbox"/> no visible remains

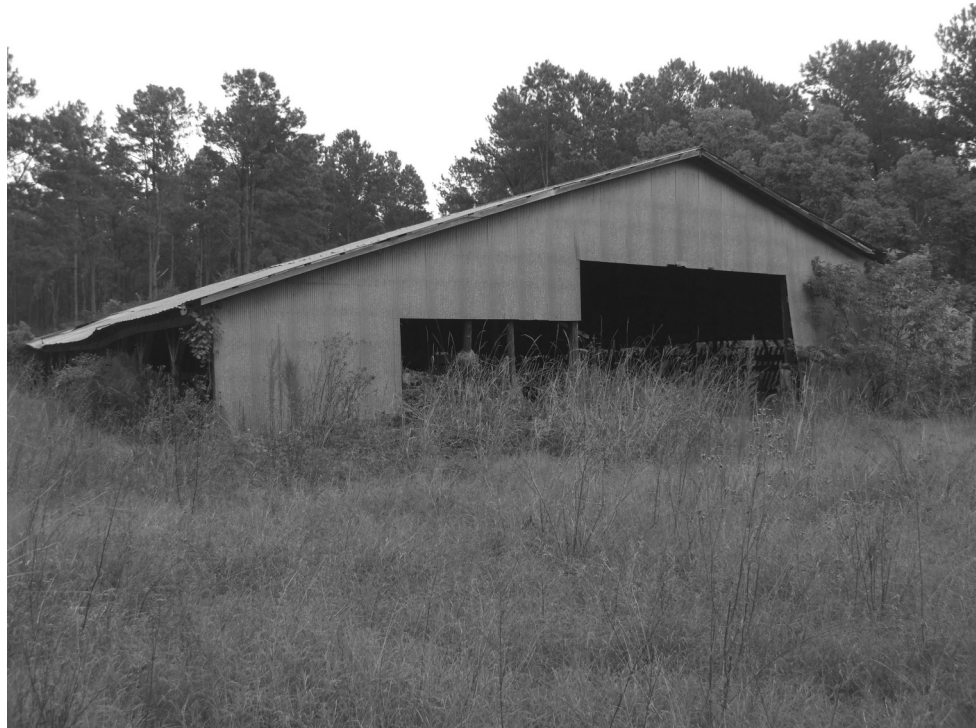
8. Brief description  Metal barn built in the late 1970's. Based on visual observations of the interior, it appears that this barn could have been originally constructed to support livestock management.  Modern trash including used tires were observed in the interior of the barn.		17. Date of construction  <input checked="" type="checkbox"/> estimated    Late 1970's <input type="checkbox"/> documented

9. Outbuildings or secondary elements (if significant, use separate form)  N/A		18. Integrity  <input type="checkbox"/> very intact <input checked="" type="checkbox"/> deteriorated <input type="checkbox"/> some changes <input type="checkbox"/> ruins <input type="checkbox"/> extensive changes <input type="checkbox"/> no visible remains

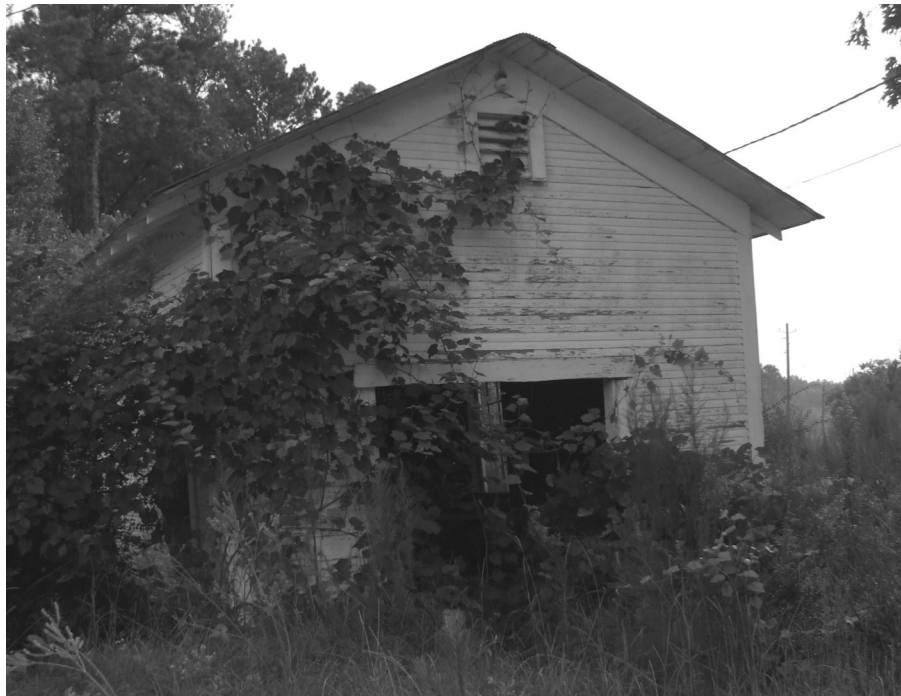
8. Brief description  The extant outbuilding is approximately 16 x 21 feet and includes a bay door opening, damaged concrete foundation, tin roof, and wood siding. The interior walls and ceiling are constructed with wood as well. No door remains on the bay opening and the window glass does not remain. Based on the damaged foundation, it is not believed that this structure is structurally sound.		17. Date of construction  <input checked="" type="checkbox"/> estimated    1920's - 1930's <input type="checkbox"/> documented

9. Outbuildings or secondary elements (if significant, use separate form)  N/A		18. Integrity  <input type="checkbox"/> very intact <input checked="" type="checkbox"/> deteriorated <input type="checkbox"/> some changes <input type="checkbox"/> ruins <input type="checkbox"/> extensive changes <input type="checkbox"/> no visible remains

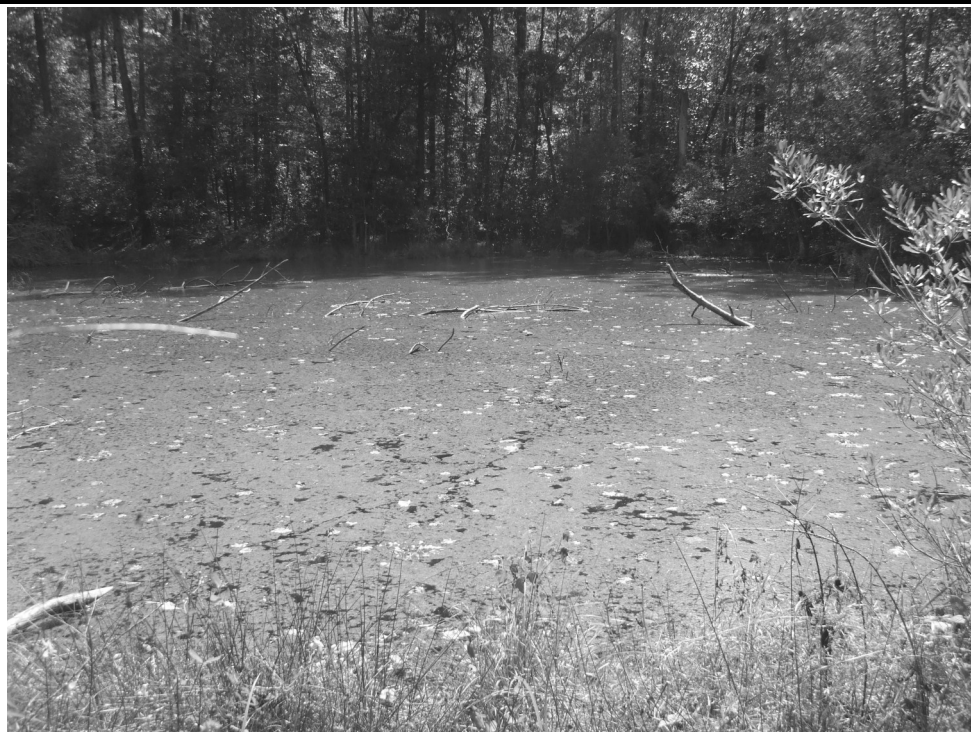
8. Brief description  This concrete-lined, spring-fed cistern once served as part of the source of the onsite water system that serviced the Columbia Training School. The water in the cistern was stagnant during the site visit, a significant amount of algae was observed, and a noticeable foul odor was associated with the cistern.  The cistern is downslope from part of the managed timber area and could contain runoff from that area and previous farming and livestock activities. The cistern is surrounded by thick underbrush, making it difficult to accurately measure. It is approximately 125 x 60 ft. in a general-ly rectangular shape.		17. Date of construction  <input checked="" type="checkbox"/> estimated    1920's <input type="checkbox"/> documented

9. Outbuildings or secondary elements (if significant, use separate form)  N/A		18. Integrity  <input type="checkbox"/> very intact <input checked="" type="checkbox"/> deteriorated <input type="checkbox"/> some changes <input type="checkbox"/> ruins <input type="checkbox"/> extensive changes <input type="checkbox"/> no visible remains

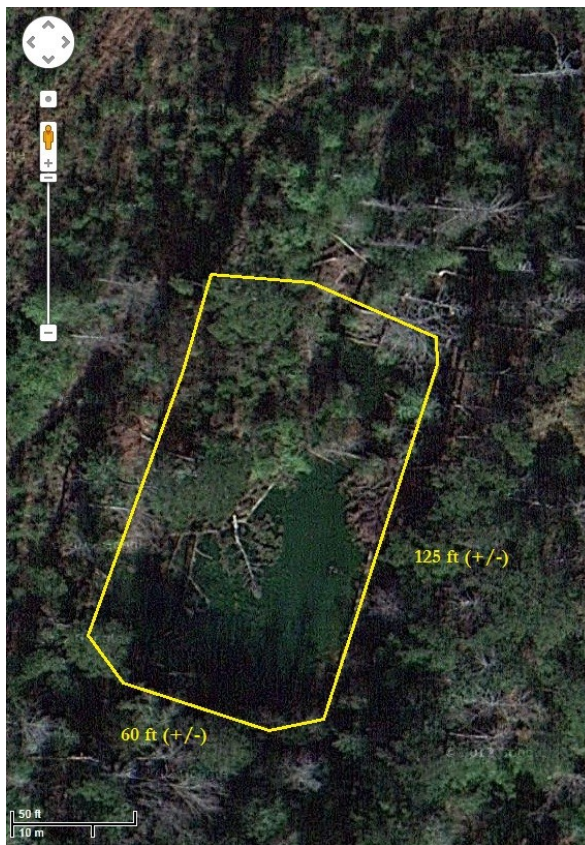
Cistern is approximately 125 x 60 feet

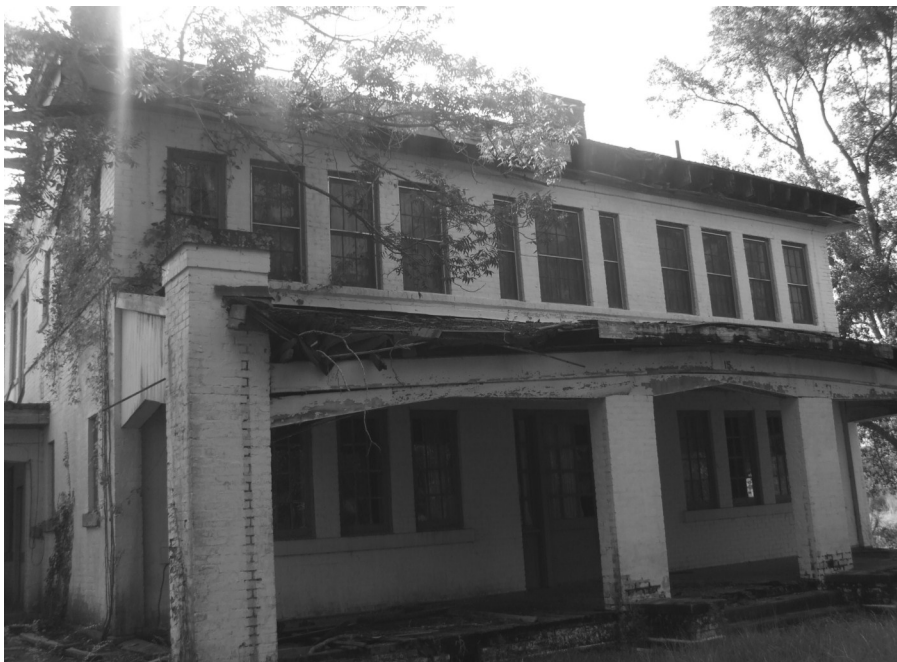
<p>1. a. Property name, historic Superintendent's Home</p> <p>b. Property name, other Superintendent's Home - MDAH Inventory 091-COL-1201-NF-ML</p>		<p>10. County Marion</p>	
<p>2. Property address/descriptive location Property of the former Columbia (MS) Training School 1730 Highway 44, Columbia, MS 39429</p>		<p>11. City or Town <input type="checkbox"/> vicinity of Columbia</p>	
<p>3. Legal description (and acreage, if required—see instructions) N/A</p>		<p>13. Was interior surveyed? Yes (limited)</p>	<p>14. Survey seq. no. 1201</p>
<p>4. Former/historic use Superintendent's Residence</p>		<p>5. Present use abandoned</p>	
<p>6. Architect Xavier A. Kramer <input checked="" type="checkbox"/> documented    <input type="checkbox"/> attributed</p>		<p>7. Builder/contractor Dobbs and Wetmore <input checked="" type="checkbox"/> documented    <input type="checkbox"/> attributed</p>	
<p>8. Brief description The Superintendent's Home is a two-story, stucco Bungalow with a gabled roof and Craftsman-style features. The foundation and walls are constructed with brick and the roof is composed of composition shingles. Heart pine timber was used in construction of the building and was never treated for termites. The front porch floor and interior floors have deteriorated and lost stability. Unstable footing inside the structure limited a survey of the interior. There are four bedrooms upstairs and two bedroom downstairs. There are two bathrooms downstairs in addition to a formal dining area and kitchen.  A detached garage/storage outbuilding is located behind the Superintendent's Home. It is believed to have been constructed in the 1960's and appears to be seen on the 1968 aerial photograph. The rectangular wood frame outbuilding has two bay doors, a concrete foundation, asphalt shingles and composition siding.</p>		<p>16. UTM reference (if required—see instructions) N31.26554 W089.80074 (NAD 27)</p>

<p>9. Outbuildings or secondary elements (if significant, use separate form) Detached Garage/Outbuilding constructed in the 1960's</p>		<p>17. Date of construction <input type="checkbox"/> estimated    1918 <input checked="" type="checkbox"/> documented</p>	
<p>18. Integrity <input type="checkbox"/> very intact    <input checked="" type="checkbox"/> deteriorated <input type="checkbox"/> some changes    <input type="checkbox"/> ruins <input type="checkbox"/> extensive changes    <input type="checkbox"/> no visible remains</p>		<p>19. Dates of changes, if any <input type="checkbox"/> moved _____ <input type="checkbox"/> enlarged/alterd _____ <input type="checkbox"/> artificial siding _____ <input type="checkbox"/> replaced windows/doors _____ <input type="checkbox"/> enclosed/alterd porch _____ <input type="checkbox"/> storefront alterations _____</p>	
<p>20. Architectural character or style Bungalow with Craftsman-style features</p>		<p>20. Architectural character or style Bungalow with Craftsman-style features</p>

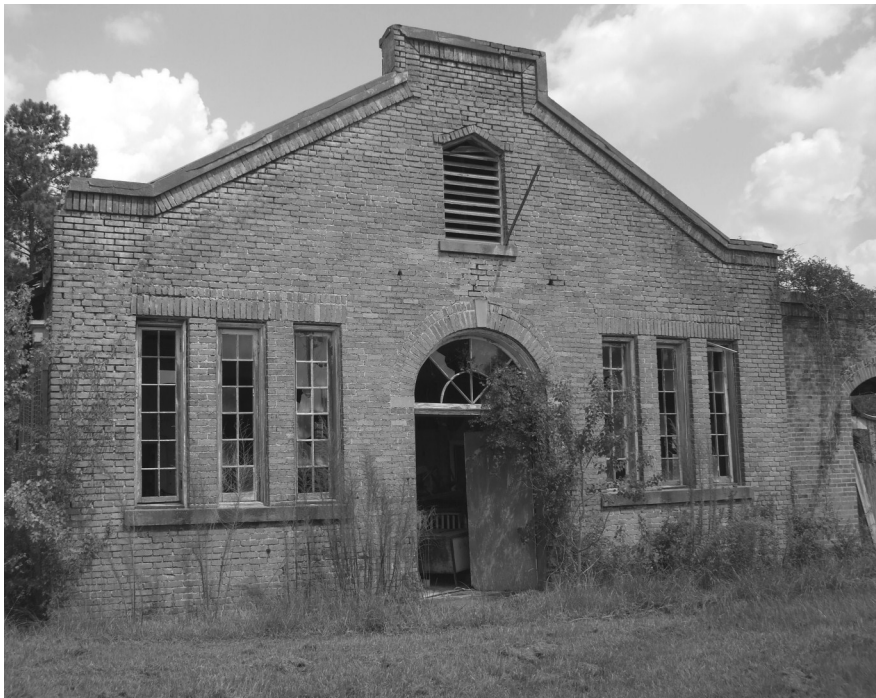
8. Brief description  This rectangular brick structure measures approximately 64 x 35 ft. The foundation is concrete and the shingles are ceramic. The front façade features six windows with wooden sashes and a door opening. The north elevation includes eighteen windows with wooden sashes. A brick boiler room appears to have been added along the south side of the building sometime after original construction. The boiler room is now dilapidated, which exposes the interior of the room.		17. Date of construction  <input checked="" type="checkbox"/> estimated      1920's <input type="checkbox"/> documented

9. Outbuildings or secondary elements (if significant, use separate form)  None		18. Integrity  <input type="checkbox"/> very intact <input checked="" type="checkbox"/> deteriorated <input type="checkbox"/> some changes <input type="checkbox"/> ruins <input type="checkbox"/> extensive changes <input type="checkbox"/> no visible remains

20. Architectural character or style		19. Dates of changes, if any  <input type="checkbox"/> moved      _____ <input checked="" type="checkbox"/> enlarged/alterd <u>unknown</u> <input type="checkbox"/> artificial siding      _____ <input type="checkbox"/> replaced windows/doors      _____ <input type="checkbox"/> enclosed/alterd porch      _____ <input type="checkbox"/> storefront alterations      _____

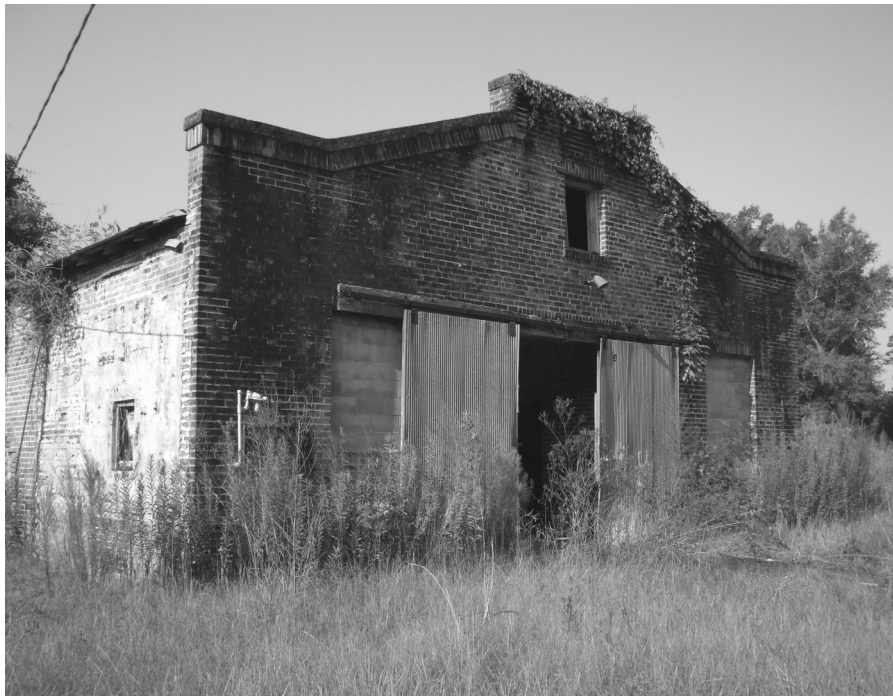
8. Brief description  The rectangular brick building measure approximately 39 x 85 ft. and feature a concrete foundation and a tin roof. The front façade includes metal bay doors and cinder blocks in place of the original bay doors. Cinder blocks also fill the original window openings.		17. Date of construction  <input checked="" type="checkbox"/> estimated      1920's <input type="checkbox"/> documented

9. Outbuildings or secondary elements (if significant, use separate form)  None		18. Integrity  <input type="checkbox"/> very intact <input checked="" type="checkbox"/> deteriorated <input checked="" type="checkbox"/> some changes <input type="checkbox"/> ruins <input type="checkbox"/> extensive changes <input type="checkbox"/> no visible remains

20. Architectural character or style		19. Dates of changes, if any  <input type="checkbox"/> moved      _____ <input type="checkbox"/> enlarged/altered      _____ <input type="checkbox"/> artificial siding      _____ <input checked="" type="checkbox"/> replaced windows/doors      unknown <input type="checkbox"/> enclosed/altered porch      _____ <input type="checkbox"/> storefront alterations      _____

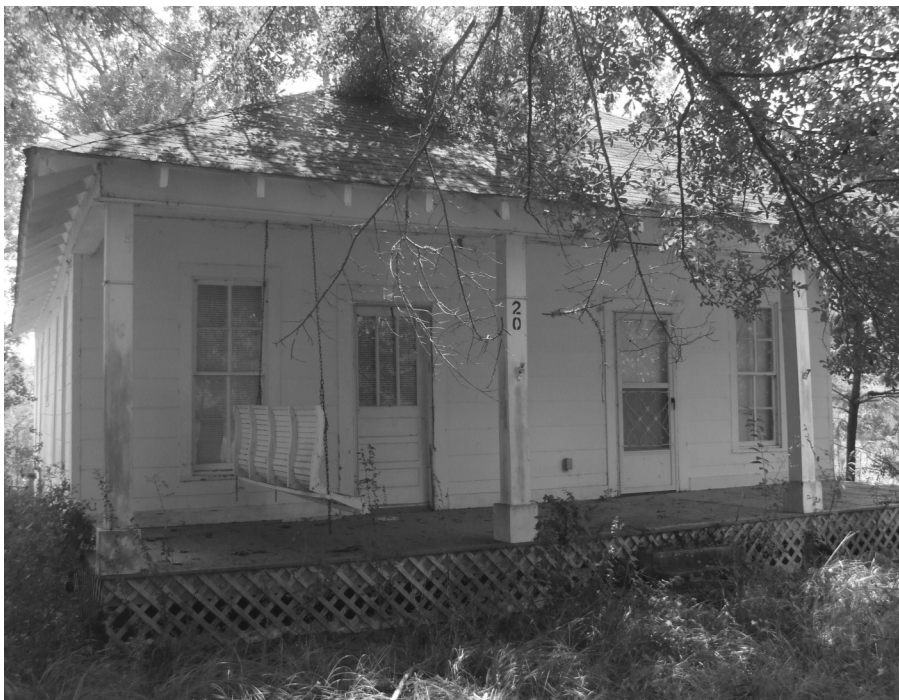
9. Outbuildings or secondary elements (if significant, use separate form)  None		18. Integrity  <input type="checkbox"/> very intact <input type="checkbox"/> deteriorated <input checked="" type="checkbox"/> some changes <input type="checkbox"/> ruins <input type="checkbox"/> extensive changes <input type="checkbox"/> no visible remains

20. Architectural character or style American Prairie		19. Dates of changes, if any  <input type="checkbox"/> moved      _____ <input checked="" type="checkbox"/> enlarged/altered <u>unknown</u> <input type="checkbox"/> artificial siding      _____ <input type="checkbox"/> replaced windows/doors      _____ <input type="checkbox"/> enclosed/altered porch      _____ <input type="checkbox"/> storefront alterations      _____

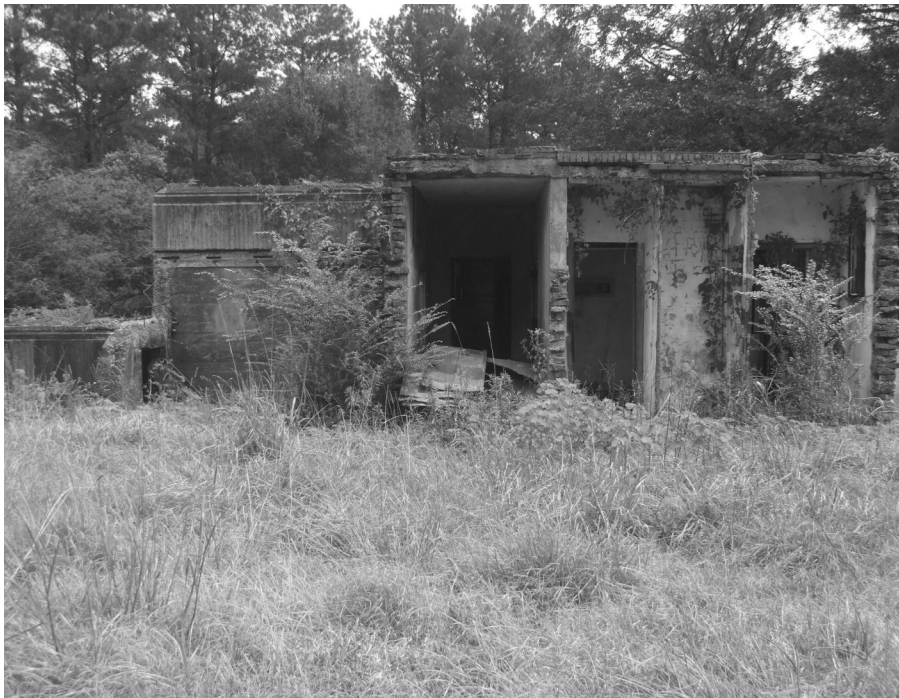
8. Brief description  The L-shaped building is constructed of brick and concrete. It features an open bay and had one center lock door prior to the deterioration of the structure. The interior currently includes two toilets but no additional improvements remain intact. The jail is dilapidated and in severe disrepair.  A "Sweat Box" room is located in the northwest corner of the jail that was reportedly used for additional discipline of students at the correctional facility.		17. Date of construction  <input checked="" type="checkbox"/> estimated      1920's <input type="checkbox"/> documented

9. Outbuildings or secondary elements (if significant, use separate form)  none		18. Integrity  <input type="checkbox"/> very intact <input checked="" type="checkbox"/> deteriorated <input type="checkbox"/> some changes <input type="checkbox"/> ruins <input type="checkbox"/> extensive changes <input type="checkbox"/> no visible remains

19. Dates of changes, if any  <input type="checkbox"/> moved _____ <input type="checkbox"/> enlarged/alterd _____ <input type="checkbox"/> artificial siding _____ <input type="checkbox"/> replaced windows/doors _____ <input type="checkbox"/> enclosed/alterd porch _____ <input type="checkbox"/> storefront alterations _____		20. Architectural character or style Concrete Jail

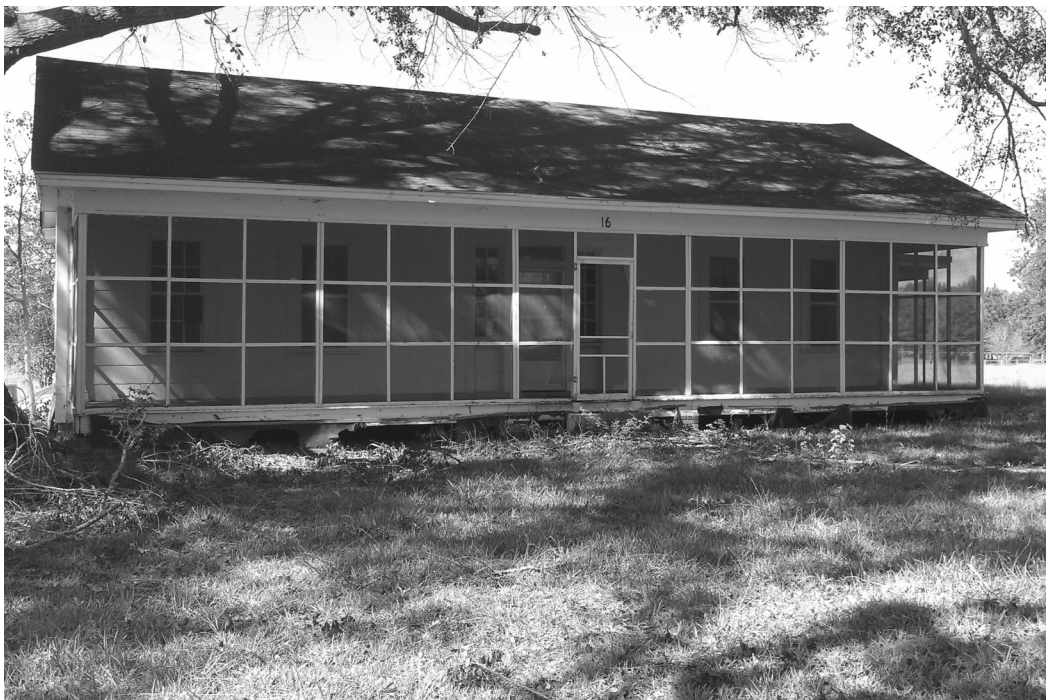
9. Outbuildings or secondary elements (if significant, use separate form) None		18. Integrity <input type="checkbox"/> very intact <input type="checkbox"/> deteriorated <input checked="" type="checkbox"/> some changes <input type="checkbox"/> ruins <input type="checkbox"/> extensive changes <input type="checkbox"/> no visible remains

10. Architectural character or style		19. Dates of changes, if any  <input type="checkbox"/> moved      _____ <input type="checkbox"/> enlarged/alterd      _____ <input type="checkbox"/> artificial siding      _____ <input type="checkbox"/> replaced windows/doors      _____ <input checked="" type="checkbox"/> enclosed/alterd porch <u>unknown</u> <input type="checkbox"/> storefront alterations      _____

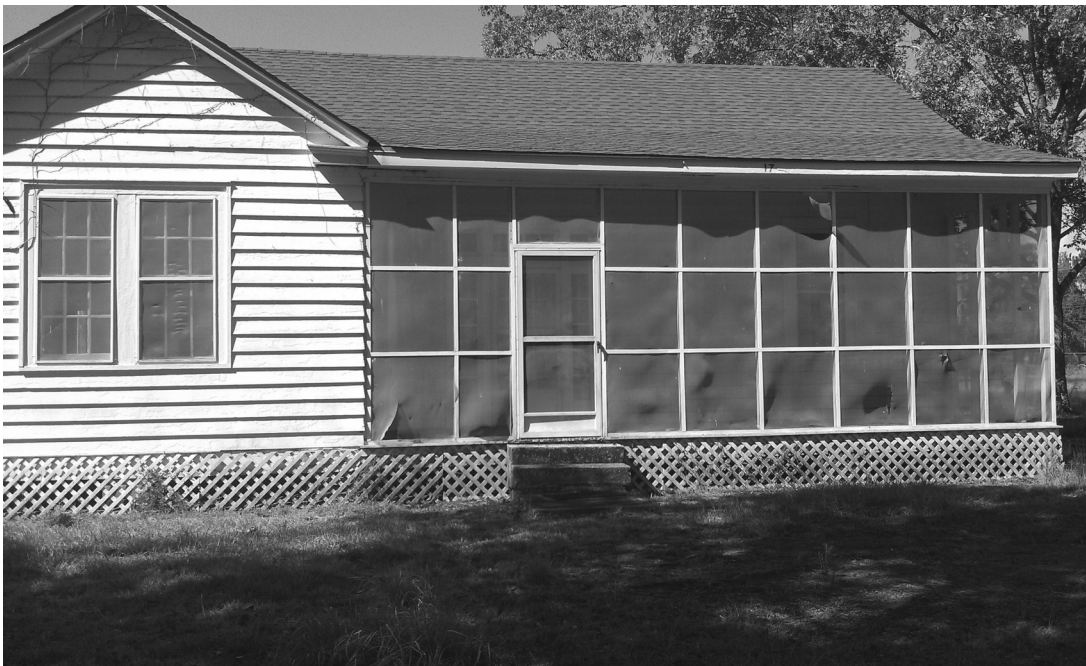
9. Outbuildings or secondary elements (if significant, use separate form)  None		18. Integrity  <input type="checkbox"/> very intact <input type="checkbox"/> deteriorated <input checked="" type="checkbox"/> some changes <input type="checkbox"/> ruins <input type="checkbox"/> extensive changes <input type="checkbox"/> no visible remains

19. Dates of changes, if any  <input type="checkbox"/> moved      _____ <input type="checkbox"/> enlarged/alterd      _____ <input type="checkbox"/> artificial siding      _____ <input type="checkbox"/> replaced windows/doors      _____ <input checked="" type="checkbox"/> enclosed/alterd porch <u>unknown</u> <input type="checkbox"/> storefront alterations      _____		20. Architectural character or style

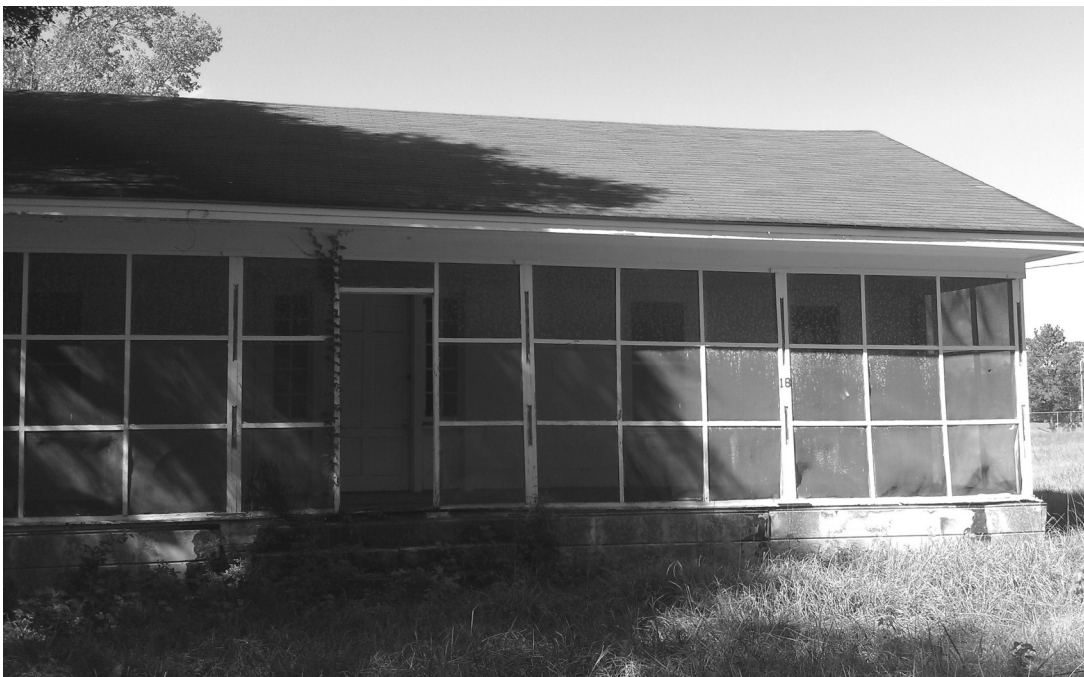
9. Outbuildings or secondary elements (if significant, use separate form)  None		18. Integrity  <input type="checkbox"/> very intact <input type="checkbox"/> deteriorated <input checked="" type="checkbox"/> some changes <input type="checkbox"/> ruins <input type="checkbox"/> extensive changes <input type="checkbox"/> no visible remains

19. Dates of changes, if any  <input type="checkbox"/> moved      _____ <input type="checkbox"/> enlarged/alterd      _____ <input type="checkbox"/> artificial siding      _____ <input type="checkbox"/> replaced windows/doors      _____ <input checked="" type="checkbox"/> enclosed/alterd porch <u>unknown</u> <input type="checkbox"/> storefront alterations      _____		20. Architectural character or style
